HERMANVILLE-CLEARSPRING WIND DEVELOPMENT

Turbine Inspection and Condition Evaluation

Prince Edward Island Energy Corporation

Document No.: 10341259-HOU-R-01

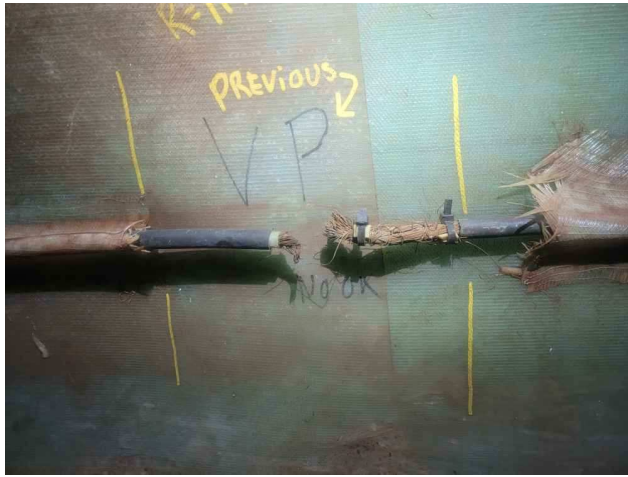
LPS inspections were conducted in 2017. DNV compared our 2022 findings to the LPS inspection reports from 2017. Previously-identified damage had not been addressed and continues to impact the functionality of the LPS (see Figure 3-1 and Figure 3-2). PEIEC confirmed that LPS repairs were not conducted following the 2017 LPS inspections [7].

Figure 3-1 Turbine T01 (blade 107) 2020 LPS damage at 0.5 m distance from the root

recommends that known LPS damage, which may significantly and adversely impact the LPS functionality, be repaired in a timely manner.

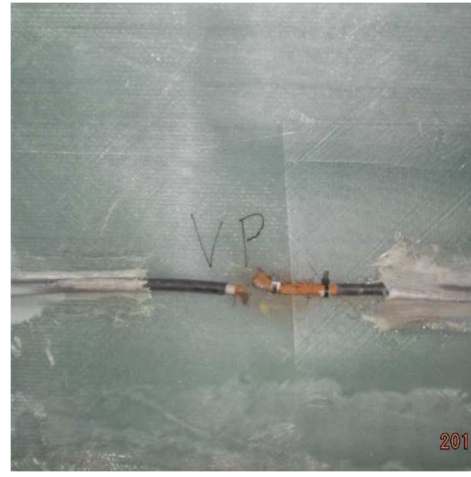
Figure 3-2 Turbine T01 (blade 107) 2017 LPS damage
Error! Reference source not found.

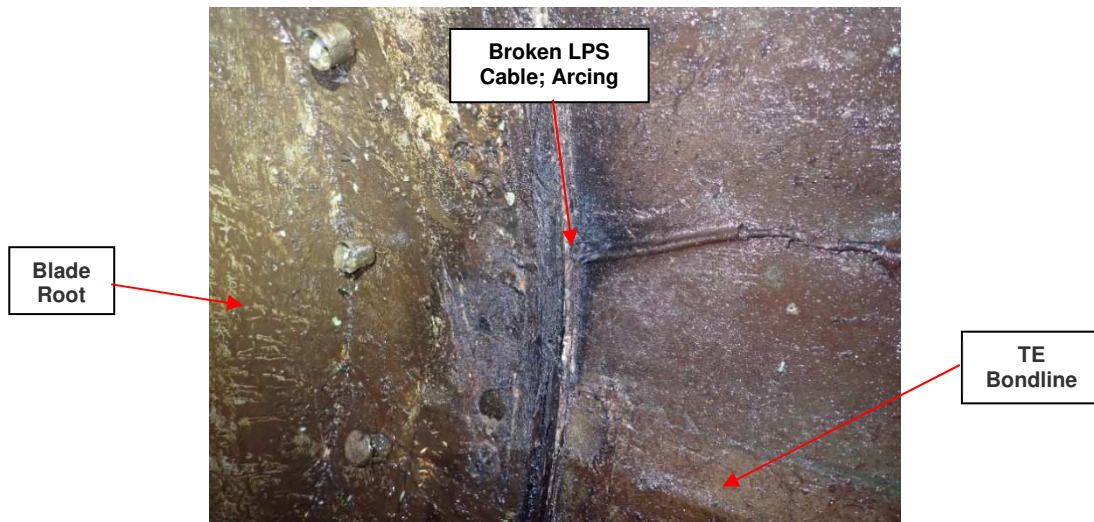
Figure 3-3 Broken LPS and evidence of arcing at turbine T09 (blade 085)

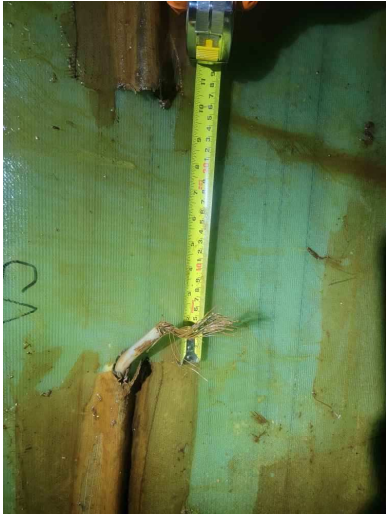
Finding ID	002
Inspection date	04-28-2022
Finding Type	Broken
Component	LPS cable
Position in Blade	SS
Location (Internal or external)	INT
Distance measured from Root Face to Bulkhead(m)	0.66
Distance measured from Bulkhead(m)	1.50
Distance from LE or TE	TE
Distance measured from LE or TE(mm)	400.00
Affected Length (mm)	250.00
Affected Width (mm)	25.00
Finding category	4
Photo

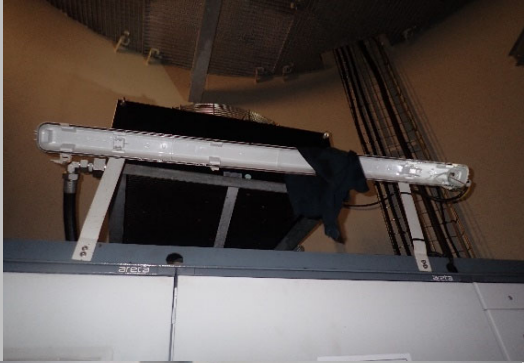
Item	System / Component	Comments	Photo	Class
2.01	Main control cabinet			1
2.02	Control panel			1
2.03	Cooling system			1
2.04	Converter			1
2.05	Breakers, switches, fuses			1
2.06	Cabling, splices			1
2.07	Grounding			1
2.08	Fans & filters			1
2.09	Light fixtures & LV	Tower light does not function

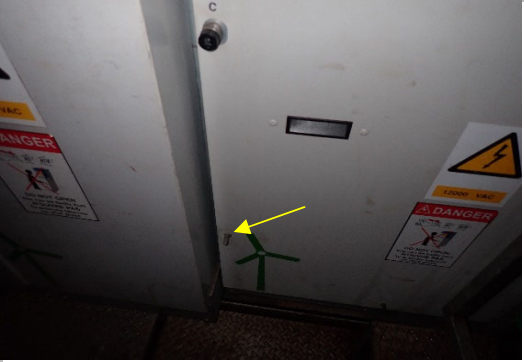
2
2.10	HV Switch gear cabinet	Switchgear cabinet missing hardware

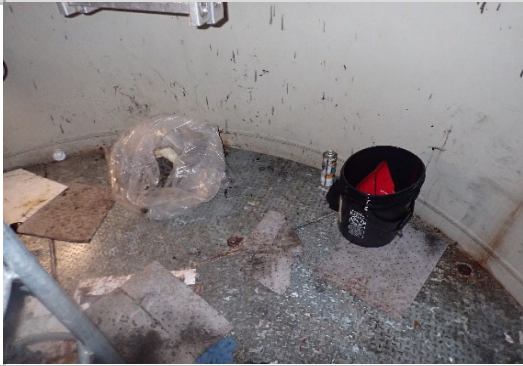
Item	System / Component	Comments	Photo	Class
5.01	Platform condition	Trash/debris remains on yaw deck

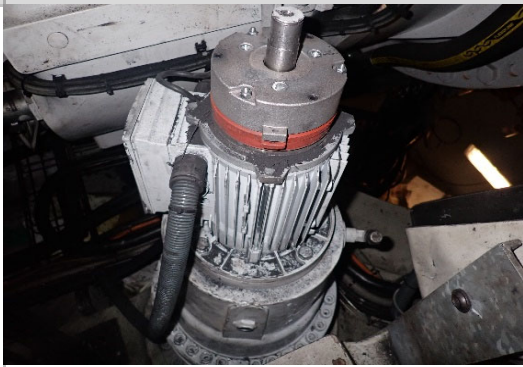
Item	System / Component	Comments	Photo	Class
5.11	Yaw motors condition	Yaw motor missing fann, excessive brake dust indicative of brake drag

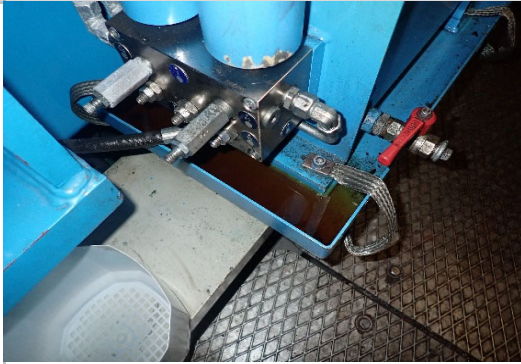
Item	System / Component	Comments	Photo	Class
6.01	Hydraulic pump condition	Moderate leakage from hydraulic unit

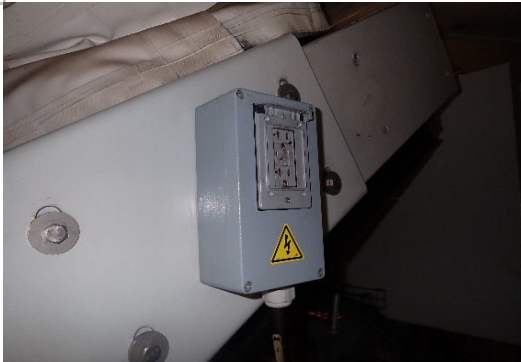
7. Nacelle				
Item	System / Component	Comments	Photo	Class
7.01	Main frame structural condition			1
7.02	Fiberglass condition, seams			1
7.03	Insulation, soundproofing			1
7.04	Light fixtures and LV	LV outlet cover missing

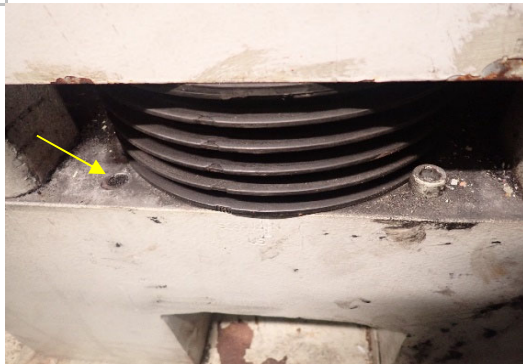
9. Gearbox				
Item	System / Component	Comments	Photo	Class
9.01	Gearbox cover condition			1
9.02	Gearbox mounting hardware	Elastomer bearing with moderate wear, placement bolt sheared for elastomer pad

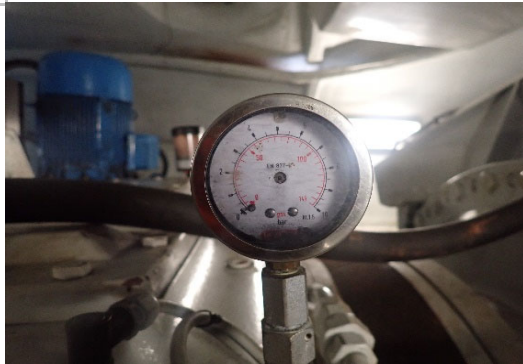
3
9.03	Gearbox access ports			1
9.04	Cooling system/circuit	Cooling line pressure gauge damaged / needle

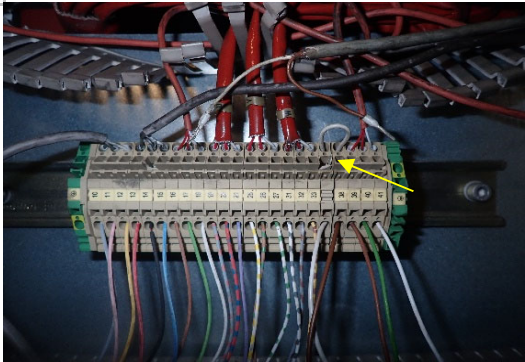
Item	System / Component	Comments	Photo	Class
10.01	Generator cover condition			1
10.02	Generator feet torque markings			1
10.03	Cooling system/circuit			1
10.04	Lubricant system			1
10.05	Generator bearings			1
10.06	Generator slip ring			1
10.07	MV cable condition, strain relief	Melting of raceway and signs of excessive heat to cables; bypassed temperature sensor pin 37 to pin 38

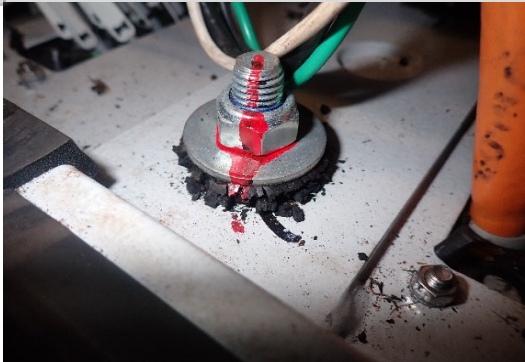
Item	System / Component	Comments	Photo	Class
11.01	Control cabinet condition	Top box mount bushing degrading

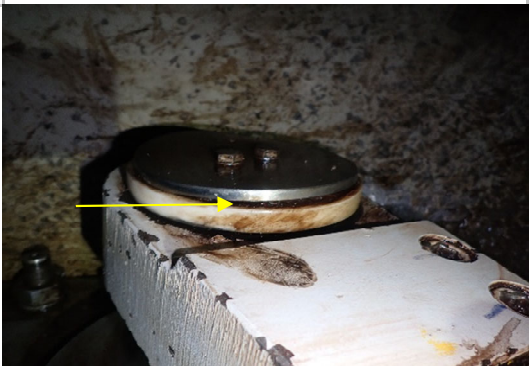
Item	System / Component	Comments	Photo	Class
12.01	Mounting hardware condition			1
12.02	Access hatch condition			1
12.03	Blade bearing seals			1
12.04	Fiberglass nose cone condition			1
12.05	Cleanliness hub internal			1
12.06	Blade internal protective covers			1
12.07	Rotating union condition			1
12.08	Control box condition			1
12.09	Light fixture and LV			1
12.10	Hydraulic system leaks			1
12.11	Pitch accumulator condition			1
12.12	Pitch ram cylinder condition	Pitch ram connection plate deflected/damaged

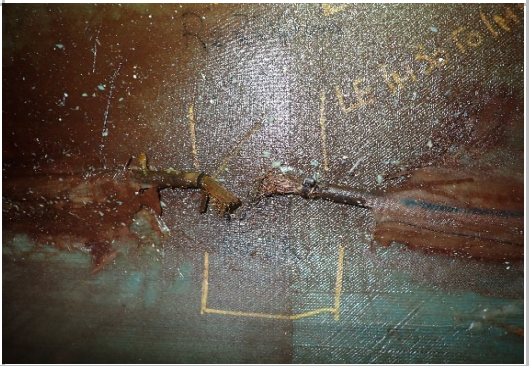
Item	System / Component	Comments	Photo	Class
13.01	Blade structural condition			1
13.02	Blade connection torque			1
13.03	Blade surface			1
13.04	Blade LPS	LPS cable damaged

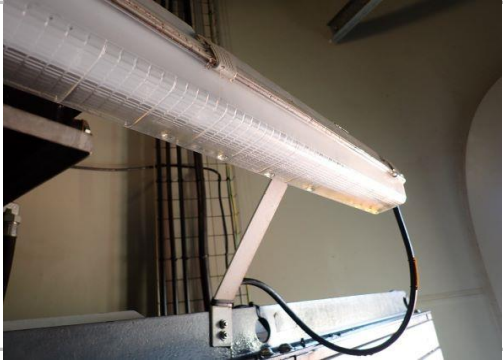
2
4.02	Ladder condition			1
4.03	Safety cable condition			1
4.04	Hatch condition			1
4.05	Tower flange condition			1
4.06	Tower walls condition			1
4.07	Bolts condition, ping test			1
4.08	Grounding straps			1
4.09	Light fixtures and LV	Light not functioning

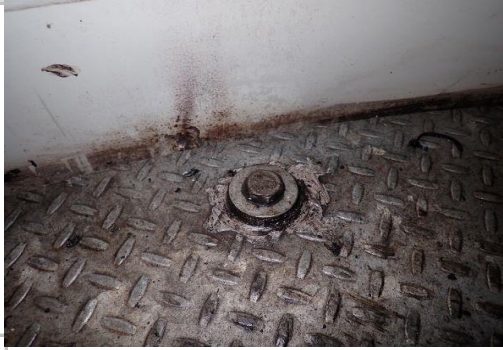
Item	System / Component	Comments	Photo	Class
5.01	Platform condition	Multiple loose hardware on platform

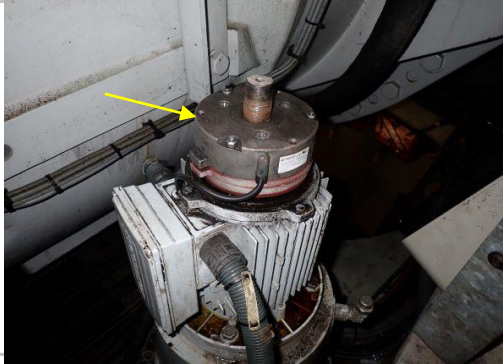
Item	System / Component	Comments	Photo	Class
5.11	Yaw motors condition			1
5.12	Yaw motors oil level, leakage			1
5.13	Yaw gear condition	Missing yaw motor fan and cover

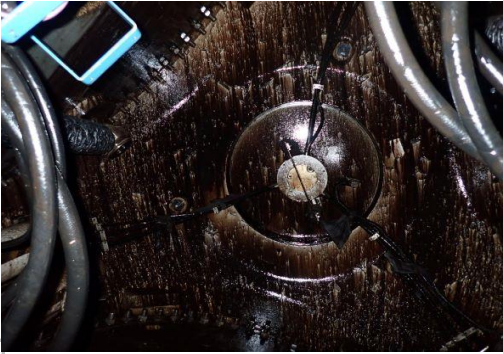
12.10	Hydraulic system leaks	Severe grease build up in hub

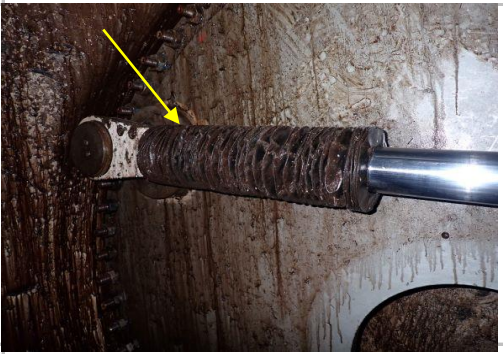
3
12.11	Pitch accumulator condition			1
12.12	Pitch ram cylinder condition	Exposed pitch ram cylinder

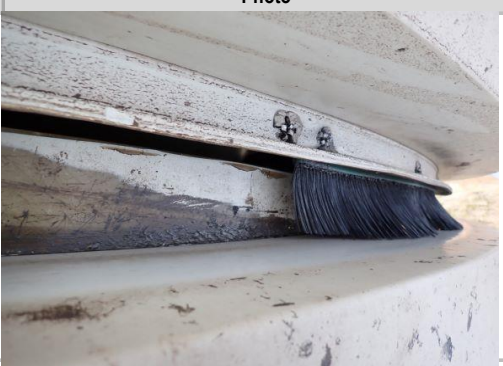
Item	System / Component	Comments	Photo	Class
13.01	Blade structural condition	Missing debris protection brush

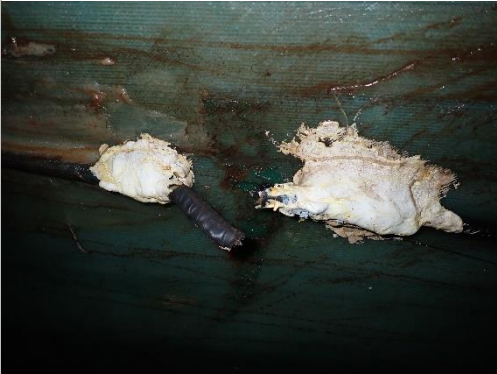
Item	System / Component	Comments	Photo	Class
13.11	Blade structural condition			1
13.12	Blade connection torque			1
13.13	Blade surface			1
13.14	Blade LPS	Disconnected/damaged LPS cable

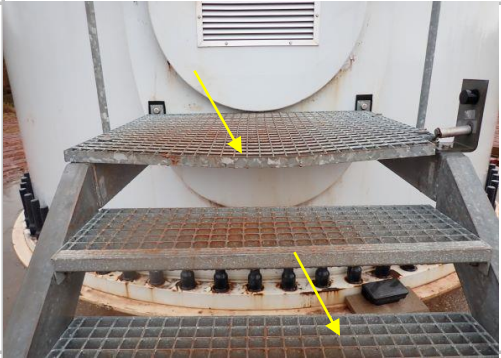
2
1.02	Foundation bolts condition			1
1.03	Tower external wall condition			1
1.04	Tower verticality check			1
1.05	Padmount transformer condition			1
1.06	Tower stairs condition	Mild deforming of top stair landing

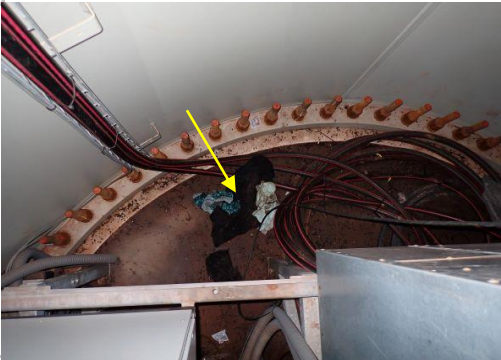
2
1.07	Tower door condition			1
1.08	Tower door flange and seals			1
1.09	Tower door hinges and lock			1
1.10	Tower door screens and filters			1
1.11	Cleanliness of basement area	Saturated rags and insects covering basement floor and cables

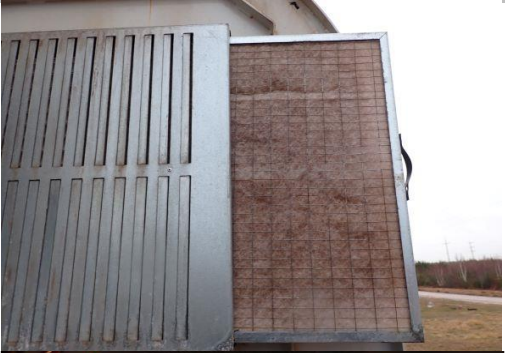
2	
2.07	Grounding			1	
2.08	Fans & filters	Door filters need replaced

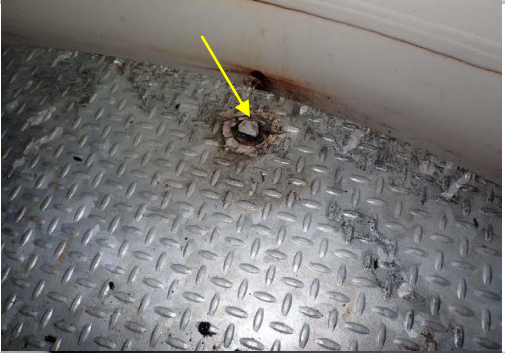
2
7.05	MV Cabling, strain reliefs			1
7.06	Grounding straps			1
7.07	Nacelle hardware, condition	Moderate corrosion on platform bolts of nacelle

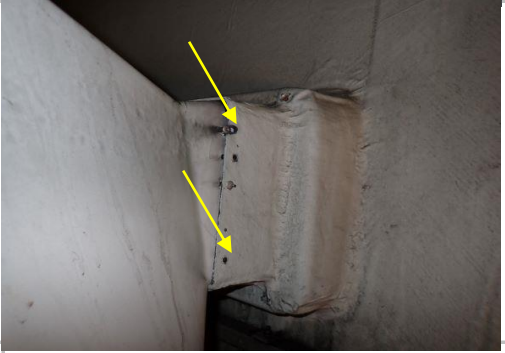
2
7.08	Hub adapter bolts, condition	Nacelle Fiberglass structure missing hardware

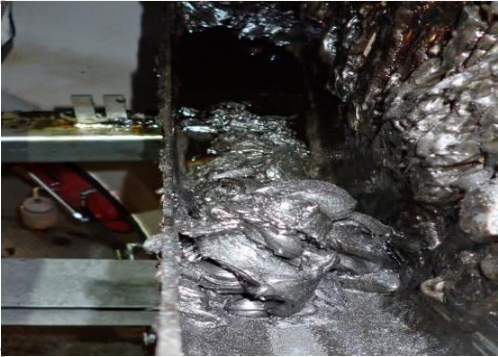
3
8.03	Main shaft condition			1
8.04	Shrink disc condition			1
8.05	Shrink disc mounting hardware			1
8.06	Grease trap	Moderate mettalic wear in grease, indicative of failed bearing

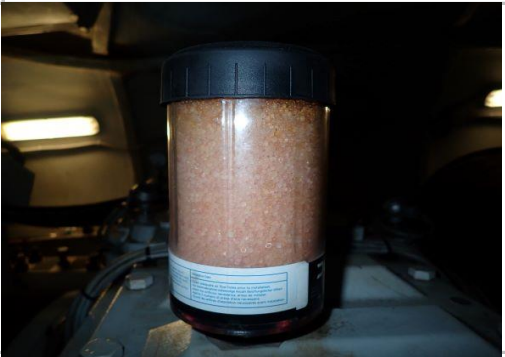
2
9.03	Gearbox access ports			1
9.04	Cooling system/circuit			1
9.05	Lubrication pump system			1
9.06	Breather filter condition			1
9.07	Gearbox oil level			1
9.08	Oil filtration system condition	Oversaturated oil breather filter

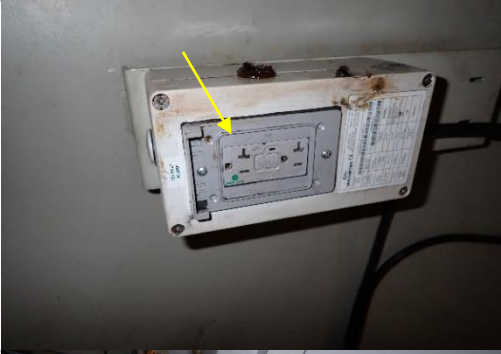
2
5.02	Access ladder condition			1
5.03	Hatch condition			1
5.04	Safety cable top assembly			1
5.05	Grounding straps			1
5.06	Light fixtures and LV	Outlet missing protection cover

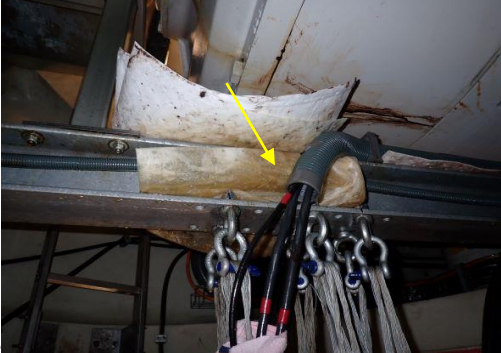
2
5.07	Saddle cable condition	Saturated pig mat dripping on cables

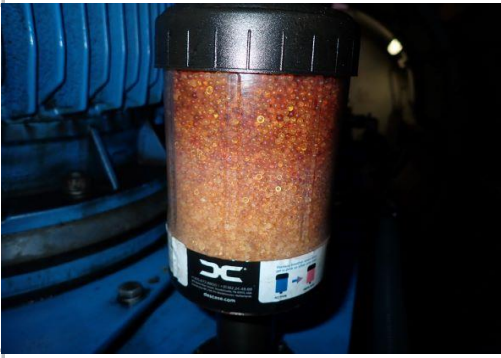
2
6.02	Accumulator condition			1
6.03	Hoses and couplings			1
6.04	Oil level, pressure	Saturated desiccant breather filter

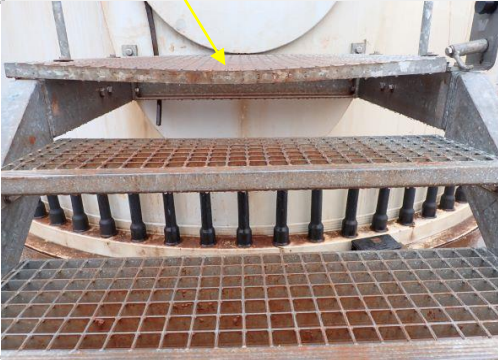
2
1.03	Tower external wall condition			1
1.04	Tower verticality check			1
1.05	Padmount transformer condition			1
1.06	Tower stairs condition	Mild deforming of stair top step

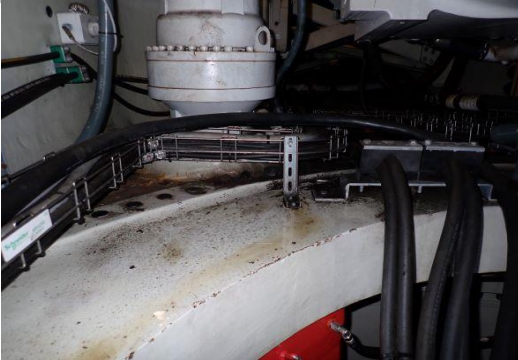
2
5.12	Yaw motors oil level, leakage	moderate leakage from yaw motor

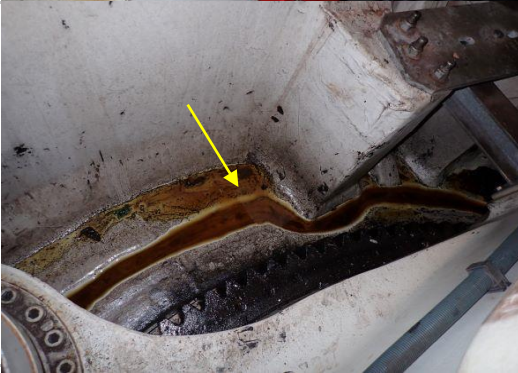
2
5.13	Yaw gear condition	Severe oil leak near yaw gear teeth

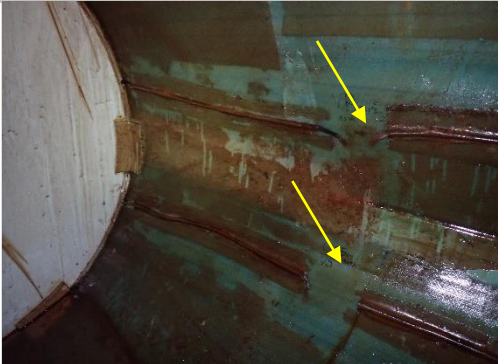
4
13.02	Blade connection torque			1
13.03	Blade surface			1
13.04	Blade LPS	Blade LPS disconnected/damaged

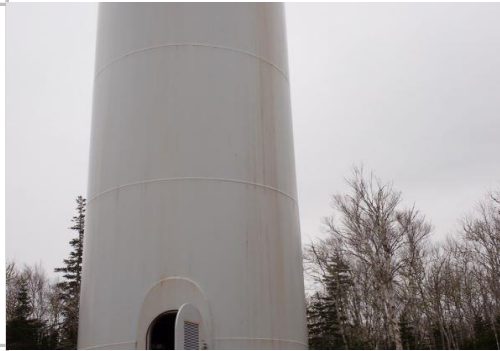
2
1.02	Foundation bolts condition			1
1.03	Tower external wall condition	Grease staining side of tower external wall
