HERMANVILLE-CLEARSPRING WIND DEVELOPMENT

Turbine Inspection and Condition Evaluation

Prince Edward Island Energy Corporation

Document No.: 10341259-HOU-R-01

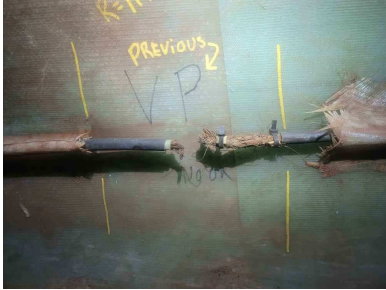
A.1.1.1 Findings - 1

Finding ID	001
Inspection date	04-29-2022
Finding Type	Broken
Component	LPS cable
Position in Blade	PS
Location (Internal or external)	INT
Distance measured from Root Face to Bulkhead(m)	0.66
Distance measured from Bulkhead(m)	1.30
Distance from LE or TE	TE
Distance measured from LE or TE(mm)	480.00
Finding Span-wise Length (mm)	200.00
Finding category	4
Photo

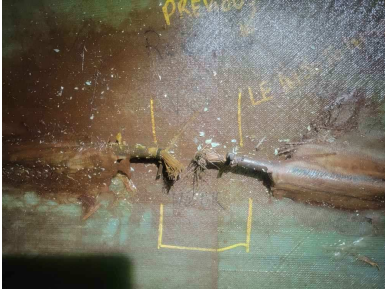
A.1.1.2 Findings - 2

Finding ID	002
Inspection date	04-29-2022
Finding Type	Broken
Component	LPS cable
Position in Blade	SS
Location (Internal or external)	INT
Distance measured from Root Face to Bulkhead(m)	0.66
Distance measured from Bulkhead(m)	1.30
Distance from LE or TE	TE
Distance measured from LE or TE(mm)	300.00
Finding Span-wise Length (mm)	250.00
Finding category	3
Photo

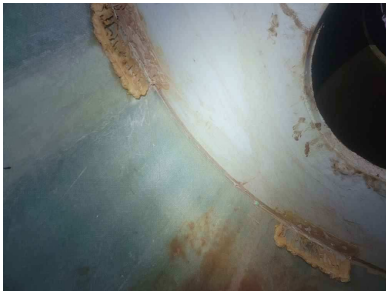
A.1.1.3 Findings - 3

Finding ID	003
Inspection date	04-29-2022
Finding Type	Debond
Component	Adhesive
Position in Blade	N/A
Location (Internal or external)	INT
Distance measured from Root Face to Bulkhead(m)	0.00
Distance measured from Bulkhead(m)	0.00
Distance from LE or TE	LE
Distance measured from LE or TE(mm)	0.00
Finding category	3
Photo

Description/Comments	Bulkhead L brackets 2 of 6 not adhered

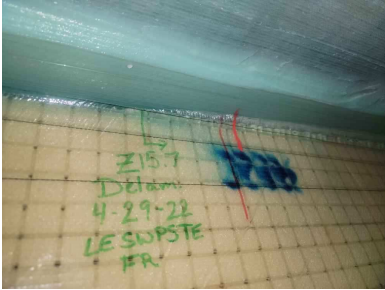
A.1.1.4 Findings - 4

Finding ID	004
Inspection date	04-29-2022
Finding Type	Delamination
Component	LE shear web
Position in Blade	LE SW PS TE Flange Radius
Location (Internal or external)	INT
Distance measured from Root Face to Bulkhead(m)	0.66
Distance measured from Bulkhead(m)	15.70
Distance from LE or TE	LE
Distance measured from LE or TE(mm)	1400.00
Finding Span-wise Length (mm)	8200.00
Finding Chord-wise Width (mm)	0.00
Finding category	3
Photo

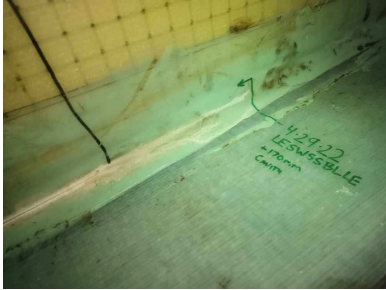
A.1.1.5 Findings - 5

Finding ID	005
Inspection date	04-29-2022
Finding Type	Void
Component	LE shear web
Position in Blade	LE SW Bondline SS LE Side
Location (Internal or external)	INT
Distance measured from Root Face to Bulkhead(m)	0.66
Distance measured from Bulkhead(m)	9.26
Distance from LE or TE	LE
Distance measured from LE or TE(mm)	1380.00
Finding Span-wise Length (mm)	3200.00
Finding category	3
Photo

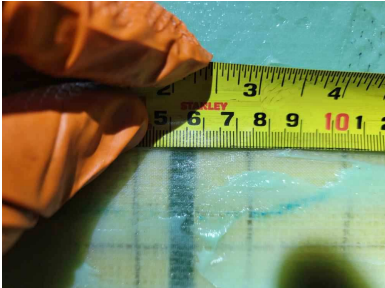
A.1.1.6 Findings - 6

Finding ID	006
Inspection date	04-29-2022
Finding Type	Gap
Component	Core material
Position in Blade	SS
Location (Internal or external)	INT
Distance measured from Root Face to Bulkhead(m)	0.66
Distance measured from Bulkhead(m)	9.29
Distance from LE or TE	LE
Distance measured from LE or TE(mm)	55.00
Finding Span-wise Length (mm)	8.00
Finding Chord-wise Width (mm)	40.00
Affected Area Percent (%)	100.00
Finding category	3
Photo

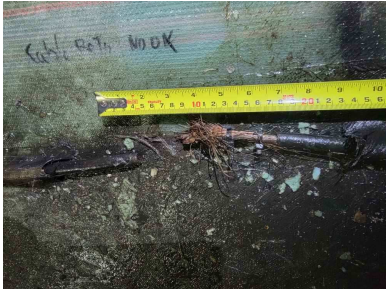
A.2.1.1 Findings - 1

Finding ID	001
Inspection date	04-26-2022
Finding Type	Broken
Component	LPS cable
Position in Blade	TE
Location (Internal or external)	INT
Distance measured from Root Face to Bulkhead(m)	0.66
Distance measured from Bulkhead(m)	1.20
Distance from LE or TE	TE
Distance measured from LE or TE(mm)	60.00
Finding Span-wise Length (mm)	200.00
Finding Chord-wise Width (mm)	10.00
Finding Depth (mm)	10.00
Finding Height (mm)	10.00
Affected Length (mm)	160.00
Finding category	4
Photo

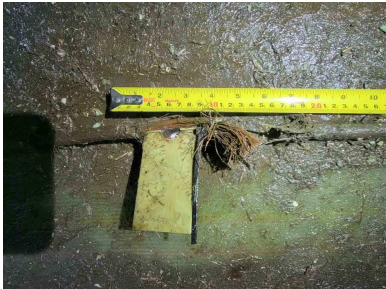
A.2.1.2 Findings - 2

Finding ID	002
Inspection date	04-26-2022
Finding Type	Broken
Component	LPS cable
Position in Blade	TE
Location (Internal or external)	INT
Distance measured from Root Face(m)	
Distance measured from Root Face to Bulkhead(m)	0.66
Distance measured from Bulkhead(m)	1.16
Distance from LE or TE	TE
Distance measured from LE or TE(mm)	240.00
Finding Span-wise Length (mm)	106.00
Finding Chord-wise Width (mm)	10.00
Finding Depth (mm)	10.00
Finding Height (mm)	10.00
Affected Length (mm)	105.00
Affected Width (mm)	10.00
Finding category	4
Photo

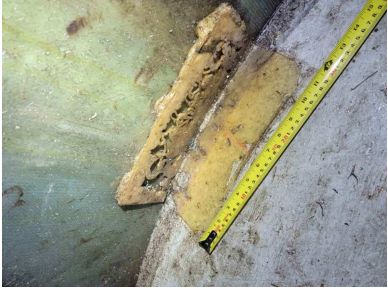
A.2.1.3 Findings - 3

Finding ID	003
Inspection date	04-26-2022
Finding Type	Debond
Component	Adhesive
Position in Blade	N/A
Location (Internal or external)	INT
Distance measured from Root Face to Bulkhead(m)	0.66
Distance measured from Bulkhead(m)	0.00
Distance from LE or TE	LE
Distance measured from LE or TE(mm)	0.00
Finding category	2
Photo

Description/Comments	Bulkhead L brackets (4 of 6) not adhered

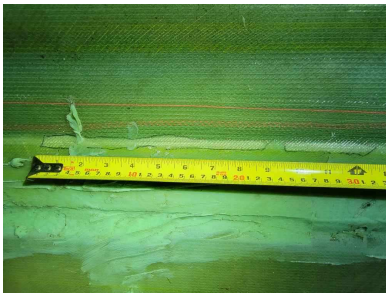
A.2.1.4 Findings - 4

Finding ID	004
Inspection date	04-26-2022
Finding Type	White laminate
Component	Laminate
Position in Blade	LE Bonding Flange
Location (Internal or external)	INT
Distance measured from Root Face to Bulkhead(m)	0.66
Distance measured from Bulkhead(m)	3.96
Distance from LE or TE	LE
Distance measured from LE or TE(mm)	80.00
Affected Length (mm)	1720.00
Affected Width (mm)	18.00
Affected Area Percent (%)	40.00
Finding category	3
Photo

Description/Comments	Delamination at LE bondline flange

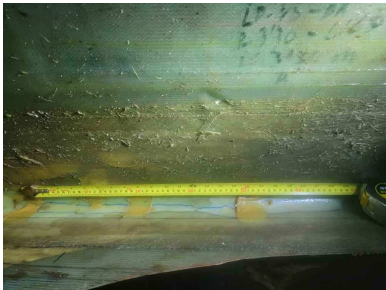
A.2.1.5 Findings - 5

Finding ID	005
Inspection date	04-26-2022
Finding Type	Delamination
Component	LE shear web
Position in Blade	LE SW Bondline SS LE Side
Location (Internal or external)	INT
Distance measured from Root Face to Bulkhead(m)	0.66
Distance measured from Bulkhead(m)	3.32
Distance from LE or TE	LE
Distance measured from LE or TE(mm)	1150.00
Finding Span-wise Length (mm)	580.00
Finding Chord-wise Width (mm)	35.00
Affected Area Percent (%)	95.00
Finding category	3
Photo

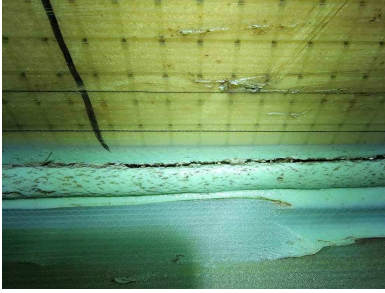
A.2.1.6 Findings - 6

Finding ID	006
Inspection date	04-26-2022
Finding Type	Void
Component	LE shear web
Position in Blade	LE SW Bondline SS LE Side
Location (Internal or external)	INT
Distance measured from Root Face to Bulkhead(m)	0.66
Distance measured from Bulkhead(m)	11.40
Distance from LE or TE	LE
Distance measured from LE or TE(mm)	1400.00
Finding Span-wise Length (mm)	7010.00
Finding category	3
Photo

Description/Comments	Cavity from Z11.40 to 18.36; growth from 13.68. last inspection 09-2-18

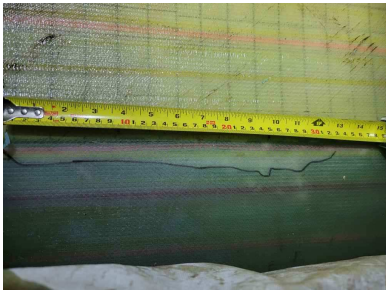
A.2.1.7 Findings - 7

Finding ID	007
Inspection date	04-26-2022
Finding Type	Dry glass
Component	Spar cap
Position in Blade	LE SW LE Side
Location (Internal or external)	INT
Distance measured from Root Face to Bulkhead(m)	0.66
Distance measured from Bulkhead(m)	17.40
Distance from LE or TE	LE
Distance measured from LE or TE(mm)	750.00
Finding Span-wise Length (mm)	345.00
Finding Chord-wise Width (mm)	35.00
Affected Area Percent (%)	100.00
Finding category	3
Photo

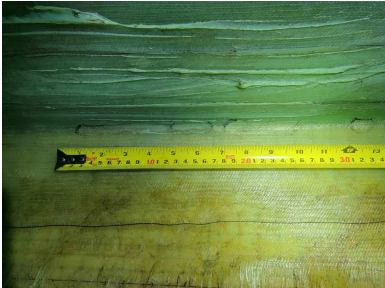
A.2.1.8 Findings - 8

Finding ID	008
Inspection date	04-26-2022
Finding Type	Delamination
Component	LE shear web
Position in Blade	LE SW Bondline PS TE Side
Location (Internal or external)	INT
Distance measured from Root Face to Bulkhead(m)	0.66
Distance measured from Bulkhead(m)	5.83
Distance from LE or TE	LE
Distance measured from LE or TE(mm)	1300.00
Finding Span-wise Length (mm)	330.00
Finding Chord-wise Width (mm)	10.00
Affected Area Percent (%)	80.00
Finding category	3
Photo

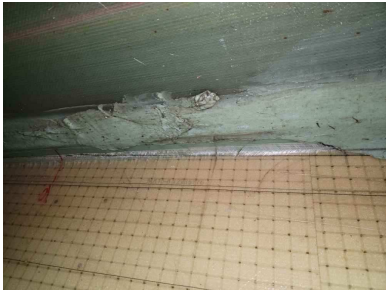
A.2.1.9 Findings - 9

Finding ID	009
Inspection date	04-26-2022
Finding Type	Delamination
Component	LE shear web
Position in Blade	LE SW Bondline PS TE Side
Location (Internal or external)	INT
Distance measured from Root Face to Bulkhead(m)	0.66
Distance measured from Bulkhead(m)	10.56
Distance from LE or TE	LE
Distance measured from LE or TE(mm)	1340.00
Finding Span-wise Length (mm)	1800.00
Finding Chord-wise Width (mm)	25.00
Affected Length (mm)	1800.00
Affected Width (mm)	25.00
Affected Area Percent (%)	100.00
Finding category	3
Photo

Description/Comments	Delamination at Z8.7 to Z10.5

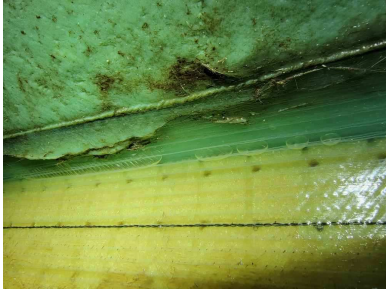
A.2.1.10 Findings - 10

Finding ID	010
Inspection date	04-26-2022
Finding Type	Air/bubbles
Component	TE shear web
Position in Blade	TE SW Bondline PS LE Side
Location (Internal or external)	INT
Distance measured from Root Face to Bulkhead(m)	0.66
Distance measured from Bulkhead(m)	13.00
Distance from LE or TE	TE
Distance measured from LE or TE(mm)	1500.00
Finding Span-wise Length (mm)	105.00
Finding category	2
Photo

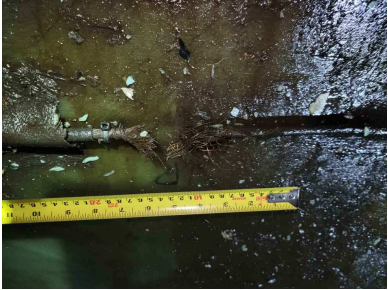
A.2.2.1 Findings - 1

Finding ID	001
Inspection date	04-26-2022
Finding Type	Broken
Component	LPS cable
Position in Blade	PS
Location (Internal or external)	INT
Distance measured from Root Face to Bulkhead(m)	0.66
Distance measured from Bulkhead(m)	1.40
Distance from LE or TE	TE
Distance measured from LE or TE(mm)	300.00
Finding Span-wise Length (mm)	160.00
Finding Chord-wise Width (mm)	10.00
Finding Depth (mm)	10.00
Finding Height (mm)	10.00
Affected Length (mm)	160.00
Affected Area Percent (%)	100.00
Finding category	4
Photo

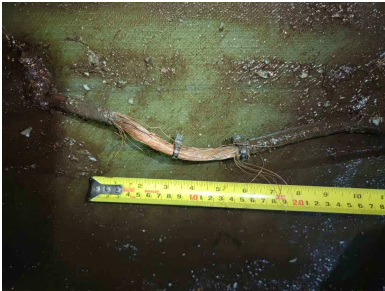
A.2.2.2 Findings - 2

Finding ID	002
Inspection date	04-26-2022
Finding Type	Broken
Component	LPS cable
Position in Blade	SS
Location (Internal or external)	INT
Distance measured from Root Face to Bulkhead(m)	0.66
Distance measured from Bulkhead(m)	1.37
Distance from LE or TE	TE
Distance measured from LE or TE(mm)	400.00
Finding Span-wise Length (mm)	130.00
Finding Chord-wise Width (mm)	10.00
Affected Area Percent (%)	100.00
Finding category	4
Photo

Description/Comments	Insulation damaged/missing from LPS cable

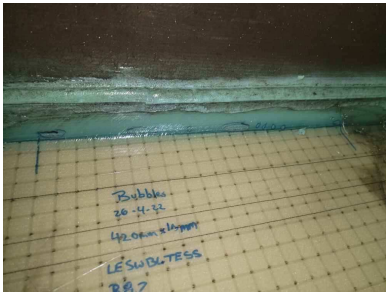
A.2.2.3 Findings - 3

Finding ID	002
Inspection date	04-26-2022
Finding Type	Air/bubbles
Component	LE shear web
Position in Blade	LE SW Bondline SS TE Side
Location (Internal or external)	INT
Distance measured from Root Face to Bulkhead(m)	0.66
Distance measured from Bulkhead(m)	8.70
Distance from LE or TE	LE
Distance measured from LE or TE(mm)	1400.00
Finding Span-wise Length (mm)	420.00
Finding Chord-wise Width (mm)	10.00
Affected Area Percent (%)	45.00
Finding category	3
Photo

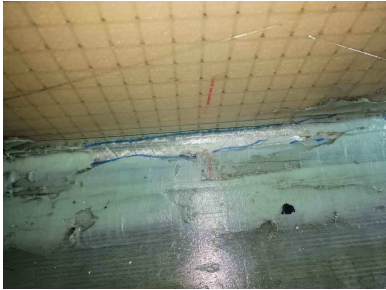
A.2.2.4 Findings - 4

Finding ID	004
Inspection date	04-26-2022
Finding Type	Delamination
Component	LE shear web
Position in Blade	LE SW Bondline PS TE Side
Location (Internal or external)	INT
Distance measured from Root Face to Bulkhead(m)	0.66
Distance measured from Bulkhead(m)	8.80
Distance from LE or TE	LE
Distance measured from LE or TE(mm)	1400.00
Finding Span-wise Length (mm)	2700.00
Finding Chord-wise Width (mm)	30.00
Affected Length (mm)	2700.00
Affected Width (mm)	30.00
Affected Area Percent (%)	100.00
Finding category	3
Photo

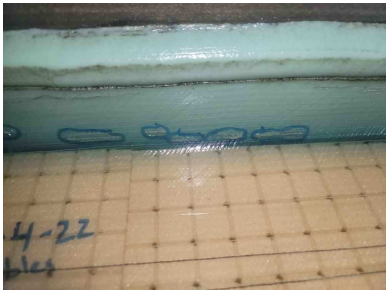
A.2.2.5 Findings - 5

Finding ID	005
Inspection date	04-26-2022
Finding Type	Air/bubbles
Component	LE shear web
Position in Blade	LE SW Bondline SS TE Side
Location (Internal or external)	INT
Distance measured from Root Face to Bulkhead(m)	0.66
Distance measured from Bulkhead(m)	14.50
Distance from LE or TE	LE
Distance measured from LE or TE(mm)	1400.00
Finding Span-wise Length (mm)	700.00
Finding Chord-wise Width (mm)	14.00
Affected Area Percent (%)	65.00
Finding category	3
Photo

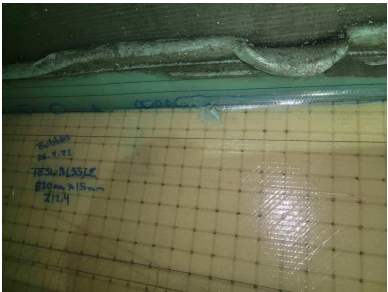
A.2.2.6 Findings - 6

Finding ID	006
Inspection date	04-26-2022
Finding Type	Air/bubbles
Component	TE shear web
Position in Blade	TE SW Bondline SS LE Side
Location (Internal or external)	INT
Distance measured from Root Face to Bulkhead(m)	0.66
Distance measured from Bulkhead(m)	12.40
Distance from LE or TE	LE
Distance measured from LE or TE(mm)	1000.00
Finding Span-wise Length (mm)	830.00
Finding Chord-wise Width (mm)	10.00
Affected Area Percent (%)	65.00
Finding category	3
Photo

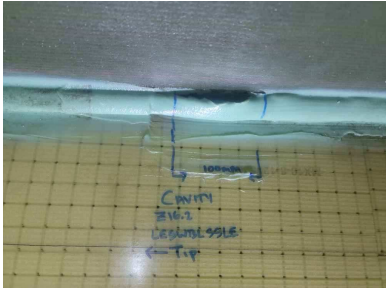
A.2.2.7 Findings - 7

Finding ID	007
Inspection date	04-26-2022
Finding Type	Void
Component	LE shear web
Position in Blade	LE SW Bondline SS LE Side
Location (Internal or external)	INT
Distance measured from Root Face to Bulkhead(m)	0.66
Distance measured from Bulkhead(m)	16.20
Distance from LE or TE	LE
Distance measured from LE or TE(mm)	1100.00
Finding Span-wise Length (mm)	100.00
Finding Chord-wise Width (mm)	3.00
Affected Length (mm)	100.00
Affected Width (mm)	3.00
Affected Area Percent (%)	100.00
Finding category	3
Photo

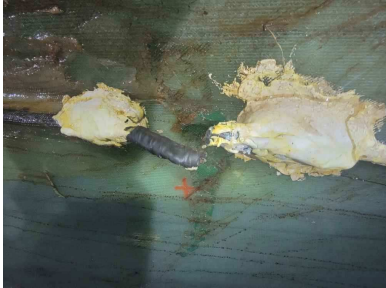
A.2.3.1 Findings - 1

Finding ID	001
Inspection date	04-26-2022
Finding Type	Broken
Component	LPS cable
Position in Blade	PS
Location (Internal or external)	INT
Distance measured from Root Face to Bulkhead(m)	0.66
Distance measured from Bulkhead(m)	2.74
Distance from LE or TE	TE
Distance measured from LE or TE(mm)	650.00
Finding category	4
Photo

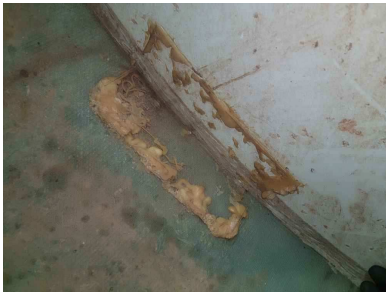
A.2.3.2 Findings - 2

Finding ID	002
Inspection date	04-26-2022
Finding Type	Debond
Component	Adhesive
Position in Blade	N/A
Location (Internal or external)	INT
Distance measured from Root Face to Bulkhead(m)	0.66
Distance measured from Bulkhead(m)	0.00
Distance from LE or TE	LE
Distance measured from LE or TE(mm)	900.00
Finding category	3
Photo

Description/Comments	Blade bulk head L brackets (2 of 6) not adhered

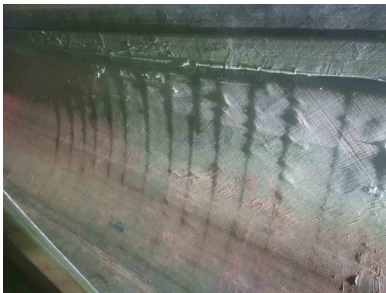
A.2.3.3 Findings - 3

Finding ID	003
Inspection date	04-26-2022
Finding Type	Wrinkle
Component	Shell
Position in Blade	SS
Location (Internal or external)	INT
Distance measured from Root Face to Bulkhead(m)	0.66
Distance measured from Bulkhead(m)	2.66
Distance from LE or TE	LE
Distance measured from LE or TE(mm)	25.00
Finding Span-wise Length (mm)	2030.00
Finding Chord-wise Width (mm)	1200.00
Affected Area Percent (%)	10.00
Finding category	2
Photo

Description/Comments	18 chordwise wrinkles with 85mm to 140 mm spacing in between

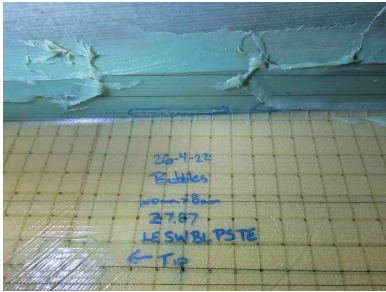
A.2.3.4 Findings - 4

Finding ID	004
Inspection date	04-26-2022
Finding Type	Air/bubbles
Component	LE shear web
Position in Blade	LE SW Bondline PS TE Side
Location (Internal or external)	INT
Distance measured from Root Face to Bulkhead(m)	0.66
Distance measured from Bulkhead(m)	7.87
Distance from LE or TE	LE
Distance measured from LE or TE(mm)	1340.00
Finding category	3
Photo

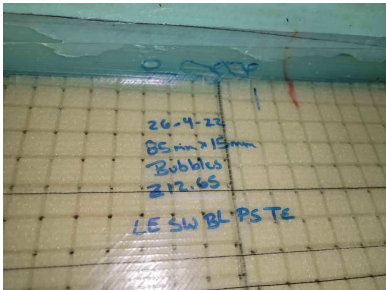
A.2.3.5 Findings - 5

Finding ID	005
Inspection date	04-26-2022
Finding Type	Air/bubbles
Component	LE shear web
Position in Blade	LE SW Bondline PS TE Side
Location (Internal or external)	INT
Distance measured from Root Face to Bulkhead(m)	0.66
Distance measured from Bulkhead(m)	12.65
Distance from LE or TE	LE
Distance measured from LE or TE(mm)	1400.00
Finding Span-wise Length (mm)	85.00
Finding Chord-wise Width (mm)	15.00
Affected Area Percent (%)	100.00
Finding category	3
Photo

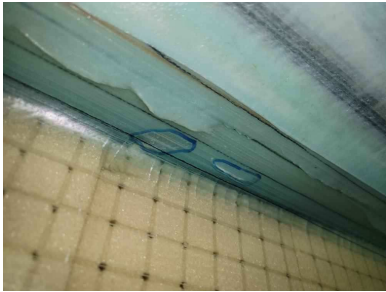
A.2.3.6 Findings - 6

Finding ID	006
Inspection date	04-26-2022
Finding Type	Air/bubbles
Component	LE shear web
Position in Blade	LE SW Bondline PS TE Side
Location (Internal or external)	INT
Distance measured from Root Face to Bulkhead(m)	0.66
Distance measured from Bulkhead(m)	11.45
Distance from LE or TE	LE
Distance measured from LE or TE(mm)	1400.00
Finding category	2
Photo

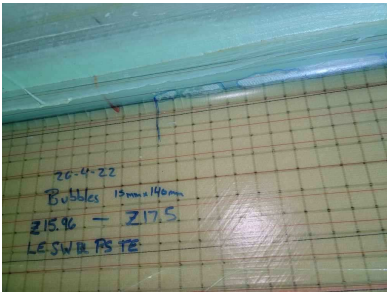
A.2.3.7 Findings - 7

Finding ID	007
Inspection date	04-26-2022
Finding Type	Air/bubbles
Component	LE shear web
Position in Blade	LE SW Bondline PS TE Side
Location (Internal or external)	INT
Distance measured from Root Face to Bulkhead(m)	0.66
Distance measured from Bulkhead(m)	15.96
Distance from LE or TE	LE
Distance measured from LE or TE(mm)	1400.00
Finding Span-wise Length (mm)	1500.00
Finding Chord-wise Width (mm)	15.00
Affected Area Percent (%)	60.00
Finding category	3
Photo

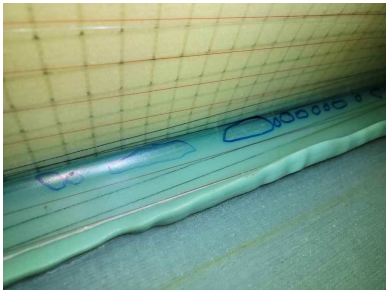
A.2.3.8 Findings - 8

Finding ID	008
Inspection date	04-26-2022
Finding Type	Air/bubbles
Component	LE shear web
Position in Blade	LE SW Bondline SS TE Side
Location (Internal or external)	INT
Distance measured from Root Face to Bulkhead(m)	0.66
Distance measured from Bulkhead(m)	16.60
Distance from LE or TE	LE
Distance measured from LE or TE(mm)	1400.00
Finding Span-wise Length (mm)	1850.00
Finding Chord-wise Width (mm)	15.00
Affected Area Percent (%)	45.00
Finding category	2
Photo

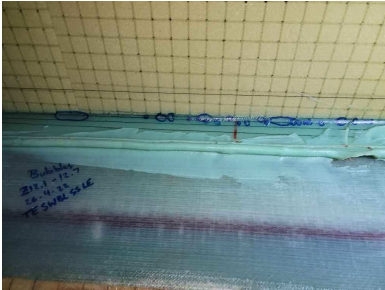
A.2.3.9 Findings - 9

Finding ID	009
Inspection date	04-26-2022
Finding Type	Air/bubbles
Component	TE shear web
Position in Blade	TE SW Bondline SS LE Side
Location (Internal or external)	INT
Distance measured from Root Face to Bulkhead(m)	0.66
Distance measured from Bulkhead(m)	12.10
Distance from LE or TE	TE
Distance measured from LE or TE(mm)	1000.00
Finding Span-wise Length (mm)	690.00
Finding Chord-wise Width (mm)	11.00
Affected Area Percent (%)	60.00
Finding category	3
Photo

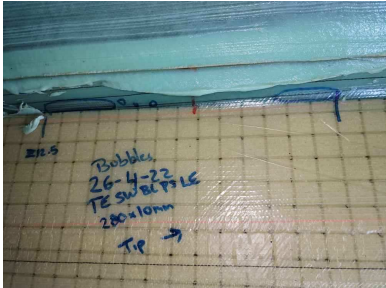
A.2.3.10 Findings - 10

Finding ID	010
Inspection date	04-26-2022
Finding Type	Air/bubbles
Component	TE shear web
Position in Blade	TE SW Bondline SS LE Side
Location (Internal or external)	INT
Distance measured from Root Face to Bulkhead(m)	0.66
Distance measured from Bulkhead(m)	12.50
Distance from LE or TE	LE
Distance measured from LE or TE(mm)	1000.00
Finding Span-wise Length (mm)	280.00
Finding Chord-wise Width (mm)	10.00
Affected Area Percent (%)	60.00
Finding category	3
Photo

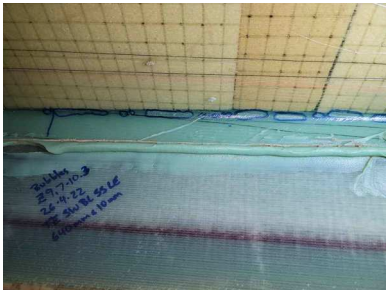
A.2.3.11 Findings - 11

Finding ID	011
Inspection date	04-26-2022
Finding Type	Air/bubbles
Component	TE shear web
Position in Blade	TE SW Bondline SS LE Side
Location (Internal or external)	INT
Distance measured from Root Face to Bulkhead(m)	0.66
Distance measured from Bulkhead(m)	9.40
Distance from LE or TE	TE
Distance measured from LE or TE(mm)	1000.00
Finding Span-wise Length (mm)	640.00
Finding Chord-wise Width (mm)	10.00
Affected Area Percent (%)	90.00
Finding category	3
Photo

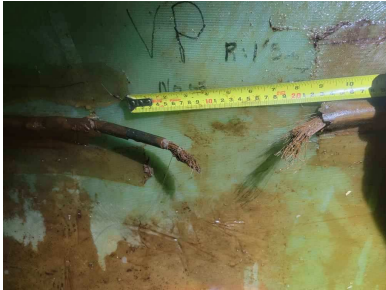
A.3.1.1 Findings - 1

Finding ID	001
Inspection date	04-28-2022
Finding Type	Broken
Component	LPS cable
Position in Blade	PS
Location (Internal or external)	INT
Distance measured from Root Face to Bulkhead(m)	0.66
Distance measured from Bulkhead(m)	1.50
Distance from LE or TE	TE
Distance measured from LE or TE(mm)	300.00
Finding Span-wise Length (mm)	400.00
Finding Chord-wise Width (mm)	20.00
Affected Length (mm)	400.00
Affected Width (mm)	20.00
Affected Area Percent (%)	400.00
Finding category	4
Photo

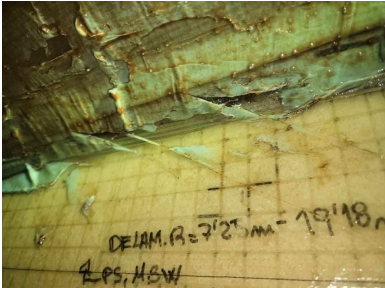
A.3.1.3 Findings - 3

Finding ID	003
Inspection date	04-28-2022
Finding Type	Delamination
Component	LE shear web
Position in Blade	LE SW Bondline PS TE Side
Location (Internal or external)	INT
Distance measured from Root Face to Bulkhead(m)	0.66
Distance measured from Bulkhead(m)	7.25
Distance from LE or TE	LE
Distance measured from LE or TE(mm)	1400.00
Finding Span-wise Length (mm)	12500.00
Finding Chord-wise Width (mm)	40.00
Affected Area Percent (%)	100.00
Finding category	3
Photo

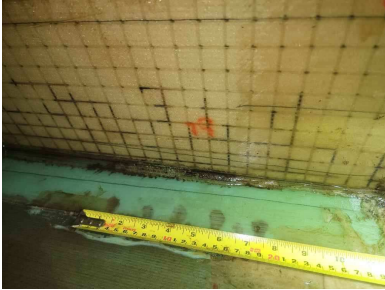
A.3.1.4 Findings - 4

Finding ID	004
Inspection date	04-28-2022
Finding Type	Delamination
Component	LE shear web
Position in Blade	LE SW Bondline PS TE Side
Location (Internal or external)	INT
Distance measured from Root Face to Bulkhead(m)	0.66
Distance measured from Bulkhead(m)	24.00
Distance from LE or TE	LE
Distance measured from LE or TE(mm)	800.00
Finding Span-wise Length (mm)	5600.00
Finding Chord-wise Width (mm)	35.00
Finding category	3
Photo

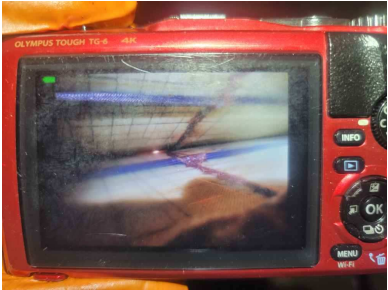
A.3.1.5 Findings - 5

Finding ID	005
Inspection date	04-28-2022
Finding Type	Crack
Component	Shell
Position in Blade	TE
Location (Internal or external)	INT
Distance measured from Root Face(m)	
Distance measured from Root Face to Bulkhead(m)	0.66
Distance measured from Bulkhead(m)	11.94
Distance from LE or TE	TE
Distance measured from LE or TE(mm)	0.00
Finding Span-wise Length (mm)	3.00
Finding Chord-wise Width (mm)	50.00
Finding category	5
Photo

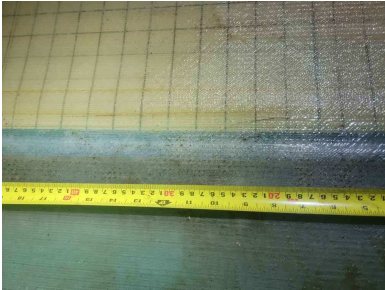
A.3.1.6 Findings - 6

Finding ID	006
Inspection date	04-28-2022
Finding Type	Delamination
Component	Spar cap
Position in Blade	SS
Location (Internal or external)	INT
Distance measured from Root Face to Bulkhead(m)	0.66
Distance measured from Bulkhead(m)	6.14
Distance from LE or TE	LE
Distance measured from LE or TE(mm)	850.00
Finding Span-wise Length (mm)	9360.00
Finding Chord-wise Width (mm)	35.00
Affected Length (mm)	9360.00
Affected Area Percent (%)	95.00
Finding category	4
Photo

Description/Comments	Z6.14 to Z15.1 LE spar cap, LE side.

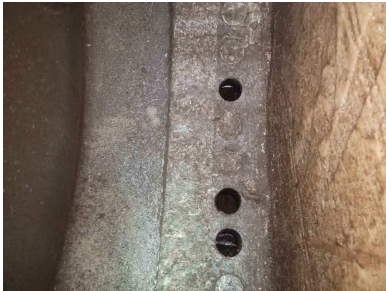
A.4.1.1 Findings - 1

Finding ID	001
Inspection date	04-27-2022
Finding Type	Blade stud
Component	Root T-bolt
Position in Blade	N/A
Location (Internal or external)	INT
Distance measured from Root Face to Bulkhead(m)	0.00
Distance measured from Bulkhead(m)	0.00
Distance from LE or TE	TE
Distance measured from LE or TE(mm)	30.00
Finding category	3
Photo

Description/Comments	3 T-bolts missing

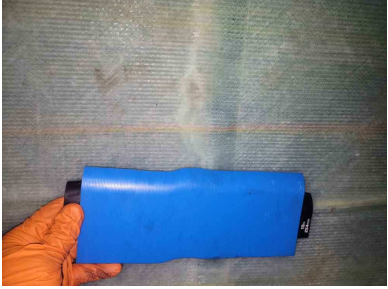
A.4.1.2 Findings - 2

Finding ID	002
Inspection date	04-27-2022
Finding Type	Wrinkle
Component	Shell
Position in Blade	PS
Location (Internal or external)	INT
Distance measured from Root Face to Bulkhead(m)	0.66
Distance measured from Bulkhead(m)	1.10
Distance from LE or TE	LE
Distance measured from LE or TE(mm)	1680.00
Finding category	4
Photo

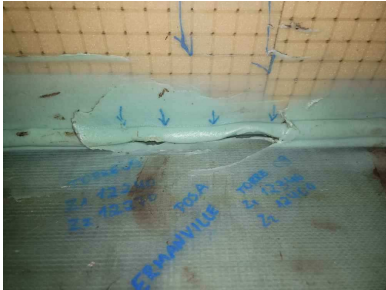
A.4.1.3 Findings - 3

Finding ID	003
Inspection date	04-27-2022
Finding Type	Void
Component	LE shear web
Position in Blade	LE SW Bondline SS LE Side
Location (Internal or external)	INT
Distance measured from Root Face to Bulkhead(m)	0.66
Distance measured from Bulkhead(m)	12.54
Distance from LE or TE	LE
Distance measured from LE or TE(mm)	1300.00
Finding Span-wise Length (mm)	2300.00
Affected Length (mm)	700.00
Affected Area Percent (%)	31.00
Finding category	3
Photo

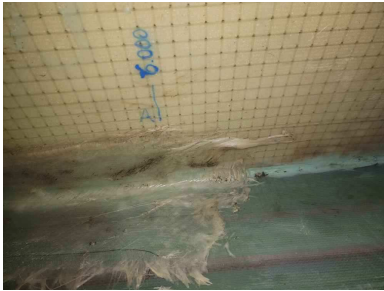
A.4.1.4 Findings - 4

Finding ID	004
Inspection date	04-27-2022
Finding Type	Observation
Component	Over laminate
Position in Blade	LE SW Bondline SS LE Side
Location (Internal or external)	INT
Distance measured from Root Face to Bulkhead(m)	0.66
Distance measured from Bulkhead(m)	13.30
Distance from LE or TE	LE
Distance measured from LE or TE(mm)	1100.00
Finding Span-wise Length (mm)	10000.00
Finding Chord-wise Width (mm)	200.00
Affected Length (mm)	10000.00
Affected Width (mm)	500.00
Affected Area Percent (%)	100.00
Finding category	4
Photo

Description/Comments	Missing position A shear clip from Z7.4 to Z13.3

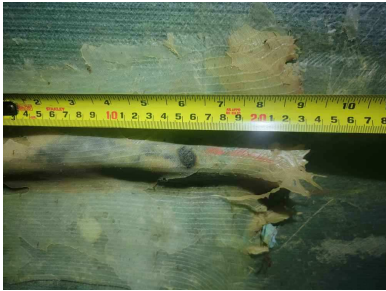
A.4.1.5 Findings - 5

Finding ID	005
Inspection date	04-27-2022
Finding Type	Other
Component	LPS cable
Position in Blade	PS
Location (Internal or external)	INT
Distance measured from Root Face to Bulkhead(m)	0.66
Distance measured from Bulkhead(m)	2.64
Distance from LE or TE	TE
Distance measured from LE or TE(mm)	600.00
Finding Span-wise Length (mm)	180.00
Finding Chord-wise Width (mm)	40.00
Affected Length (mm)	180.00
Affected Width (mm)	40.00
Affected Area Percent (%)	100.00
Finding category	4
Photo

Description/Comments	Lighting damage on overlaminates of LPS cable on PS. Exit charring present

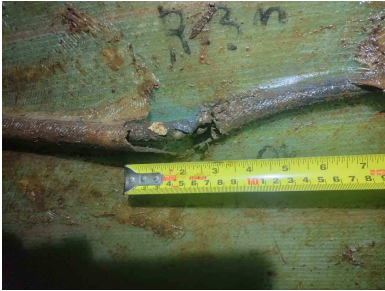
A.4.2.1 Findings - 1

Finding ID	001
Inspection date	04-27-2022
Finding Type	Broken
Component	LPS cable
Position in Blade	PS
Location (Internal or external)	INT
Distance measured from Root Face to Bulkhead(m)	-0.26
Distance measured from Bulkhead(m)	3.40
Distance from LE or TE	TE
Distance measured from LE or TE(mm)	550.00
Finding Span-wise Length (mm)	100.00
Finding Chord-wise Width (mm)	15.00
Affected Area Percent (%)	100.00
Finding category	3
Photo

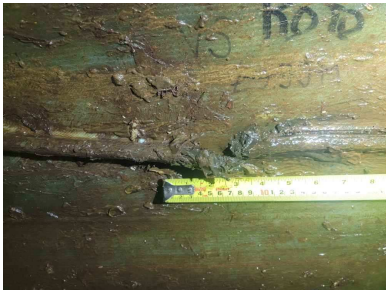
A.4.2.2 Findings - 2

Finding ID	002
Inspection date	04-27-2022
Finding Type	Broken
Component	LPS cable
Position in Blade	SS
Location (Internal or external)	INT
Distance measured from Root Face to Bulkhead(m)	-0.26
Distance measured from Bulkhead(m)	3.40
Distance from LE or TE	TE
Distance measured from LE or TE(mm)	370.00
Finding Span-wise Length (mm)	60.00
Finding Chord-wise Width (mm)	1.00
Affected Area Percent (%)	100.00
Finding category	4
Photo

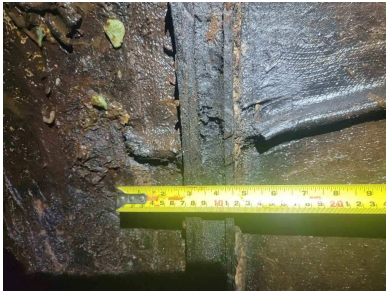
A.4.2.3 Findings - 3

Finding ID	003
Inspection date	04-27-2022
Finding Type	Observation
Component	Laminate
Position in Blade	PS
Location (Internal or external)	INT
Distance measured from Root Face to Bulkhead(m)	-0.26
Distance measured from Bulkhead(m)	0.55
Distance from LE or TE	TE
Distance measured from LE or TE(mm)	500.00
Finding Span-wise Length (mm)	150.00
Finding Chord-wise Width (mm)	150.00
Affected Area Percent (%)	95.00
Finding category	4
Photo

Description/Comments	Evidence of lightning strike/arcing at LPS termination point. Charred laminate/glass multiple layers deep. Missing bulkhead in blade.

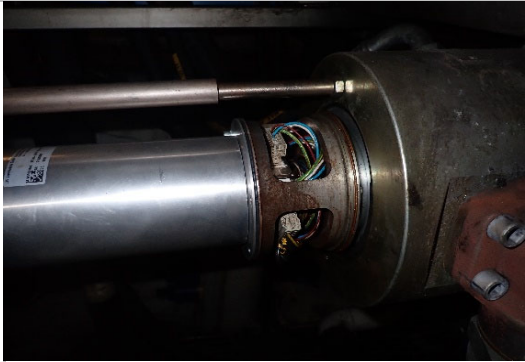
9.10	Pitch slip-ring, rotating union	Rotating union/slipping wiring cover removed

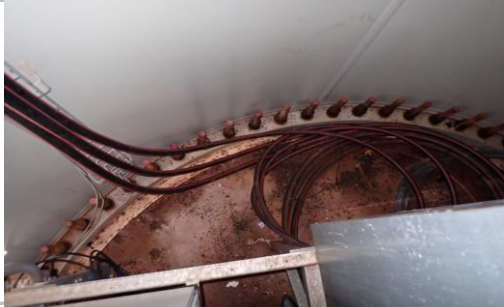
1.07	Tower door condition			1
1.08	Tower door flange and seals			1
1.09	Tower door hinges and lock			1
1.10	Tower door screens and filters			1
1.11	Cleanliness of basement area	Moderate amount of insects and debris in basement

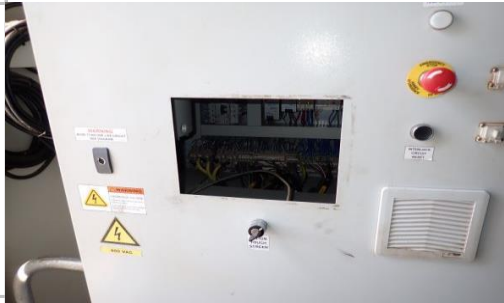
Item	System / Component	Comments	Photo	Class
2.01	Main control cabinet			1
2.02	Control panel	Missing CPU Interface

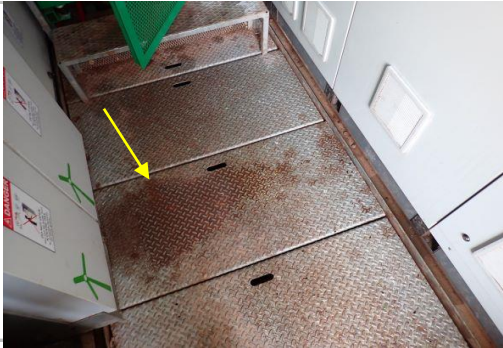
4.01	Platform condition	Dirt/Oil on diamond plate/platform

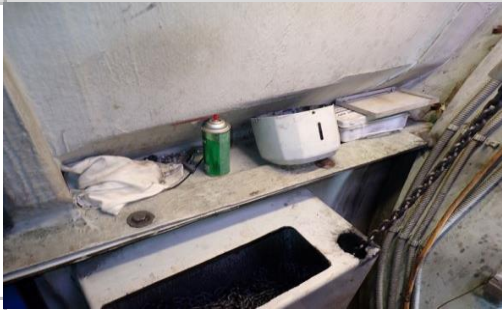
Item	System / Component	Comments	Photo	Class
7.01	Main frame structural condition	Debris and hardware left on nacelle structure

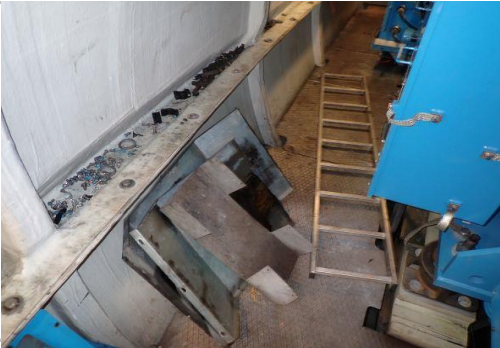
7.07	Nacelle hardware, condition	Hardware and protection coverings cluttering frame and platform

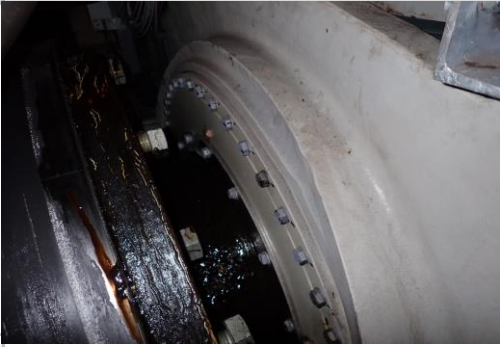
Item	System / Component	Comments	Photo	Class
8.01	Main bearing condition	Missing protection covering/shield

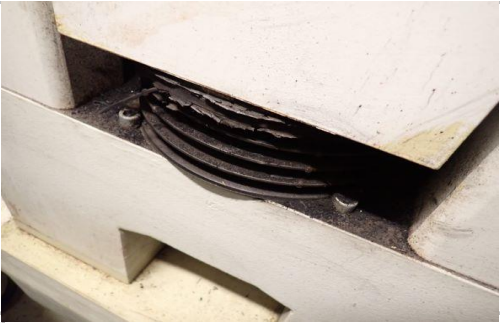
9.02	Gearbox mounting hardware	Moderate wear on elastomer bearings

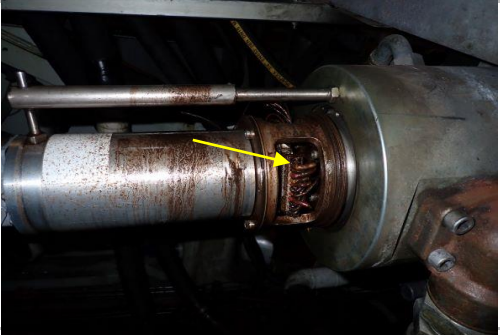
2
9.03	Gearbox access ports			1
9.04	Cooling system/circuit			1
9.05	Lubrication pump system			1
9.06	Breather filter condition			1
9.07	Gearbox oil level			1
9.08	Oil filtration system condition			1
9.09	Hoses and couplings			1
9.10	Pitch slip-ring, rotating union	Slip ring missing protection cover and oil forming inside junction box

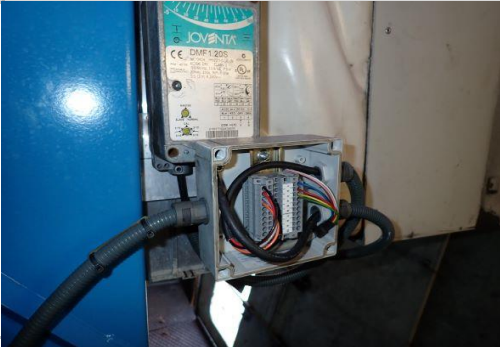
Item	System / Component	Comments	Photo	Class
10.01	Generator cover condition	Generator cooling actuator missing cable junction box cover

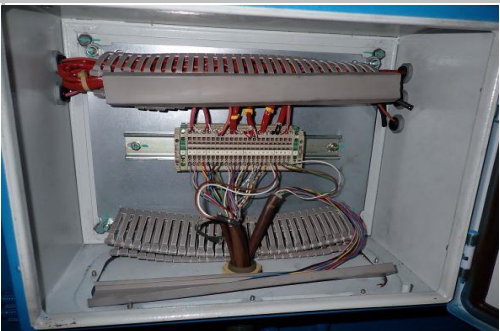
2
10.02	Generator feet torque markings			1
10.03	Cooling system/circuit	Generator raceway melting in junction box

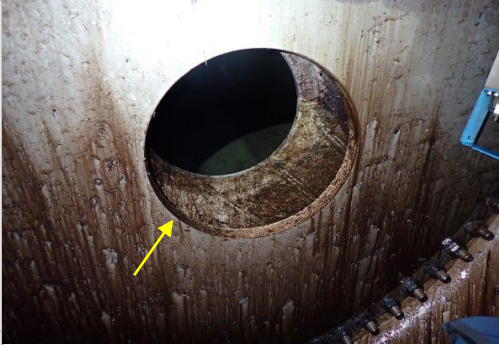
Item	System / Component	Comments	Photo	Class
12.01	Mounting hardware condition			
12.02	Access hatch condition	Missing both close of hatches - significant potential for personnel falling into blade

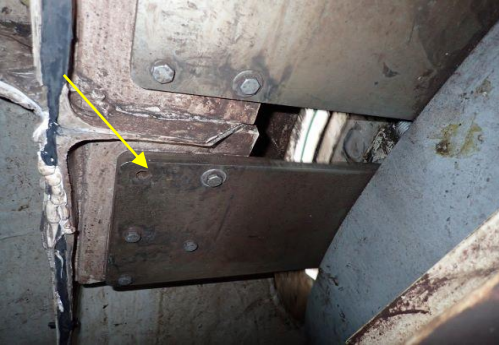
4
12.03	Blade bearing seals			1
12.04	Fiberglass nose cone condition	Missing hardware on blade bearing structure

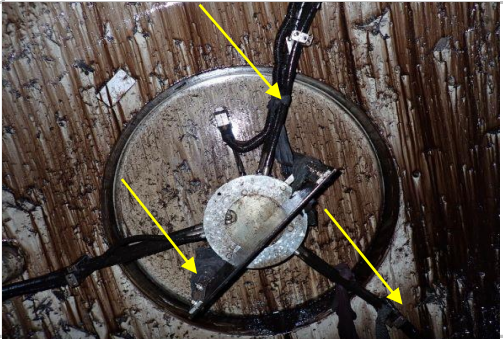
2
12.13	Pitch cylinder bearing condition			1
12.14	Pitch cylinder connection points	Grease saturated rags tied to connection points

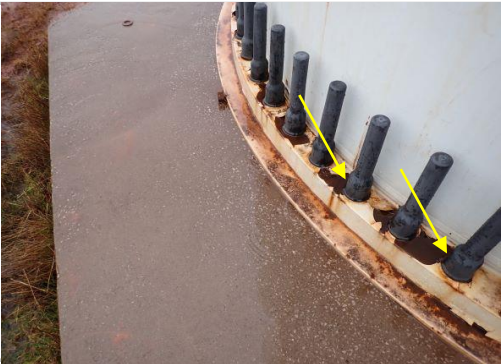
1.01	Foundation concrete condition	Moderate corrosion and paint chipping around bases of foundation bolts

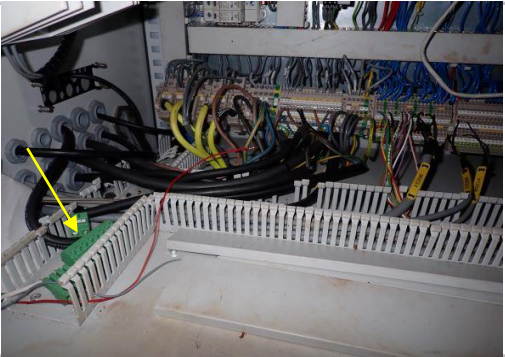
WIND TURBINE VISUAL INSPECTION		Wind Farm:	Hernanville Wind farm	DNV	
		Wind Turbine:	T-6		
2.01	Main control cabinet	Unused components and cables left on raceway

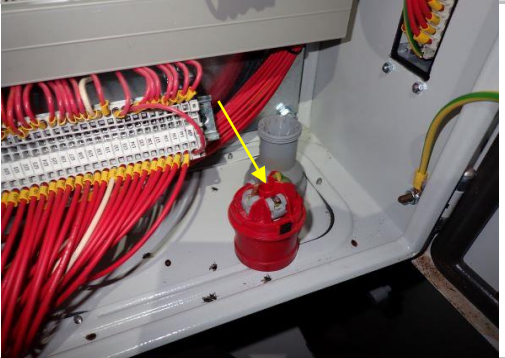
2	
2.02	Control panel			1	
2.03	Cooling system			1	
2.04	Converter			1	
2.05	Breakers, switches, fuses			1	
2.06	Cabling, splices	Unused plug cut and left in cabinet

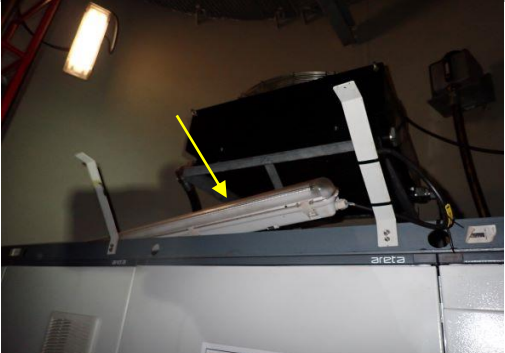
2	
2.09	Light fixtures & LV	Light not functioning

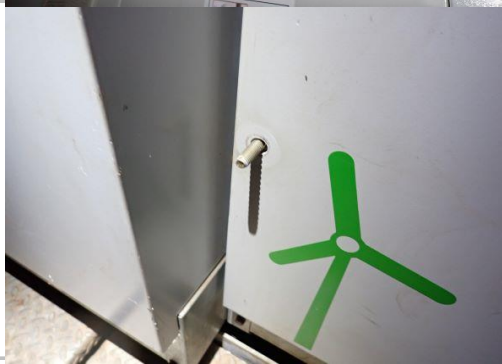
2.10	HV Switch gear cabinet	Missing hardware

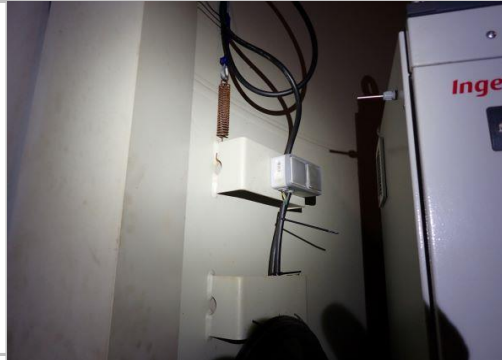
Item	System / Component	Comments	Photo	Class
4.01	Platform condition			1
4.02	Ladder condition			1
4.03	Safety cable condition			1
4.04	Hatch condition			1
4.05	Tower flange condition			1
4.06	Tower walls condition			1
4.07	Bolts condition, ping test			1
4.08	Grounding straps			1
4.09	Light fixtures and LV	Tower lighting does not function

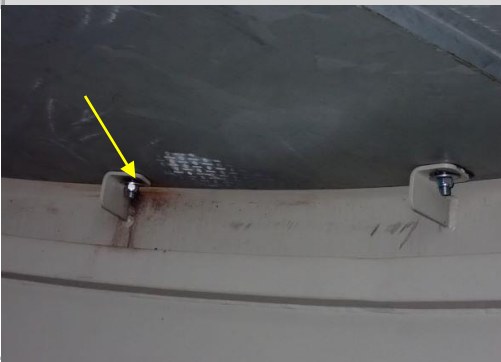
5. Yaw System				
Yaw Deck				
Item	System / Component	Comments	Photo	Class
5.01	Platform condition	Loose hardware on bottom side of platform

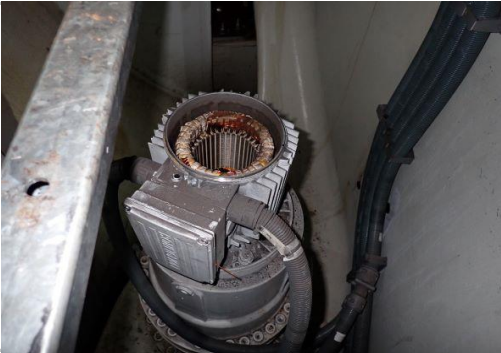
5.11	Yaw motors condition	Missing motor cover exposing rotor windings

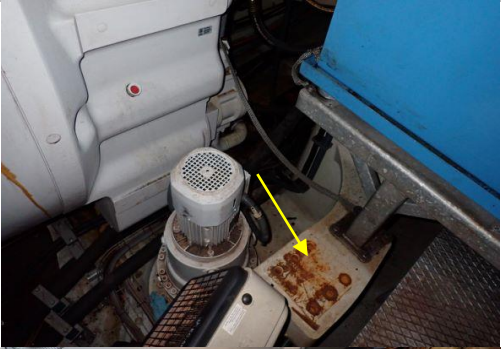
Item	System / Component	Comments	Photo	Class
7.01	Main frame structural condition	Moderate corrosion near footing of generator

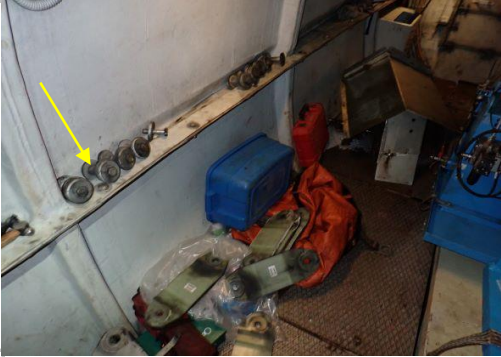
2
7.02	Fiberglass condition, seams	Hardware left on fiberglass nacelle housing

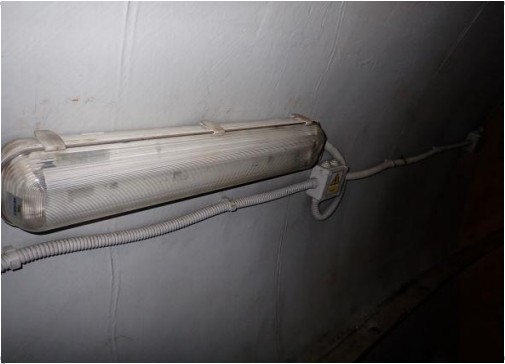
7.04	Light fixtures and LV	Light not functioning

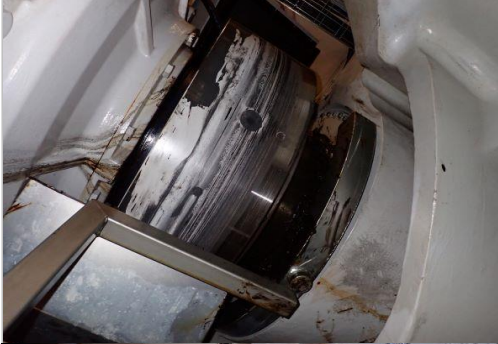
8.01	Main bearing condition	Failed main bearing - replacement required

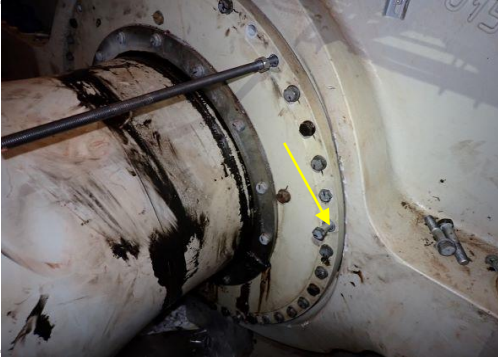
4
8.02	Main bearing mounting hardware	Loose and missing hardware

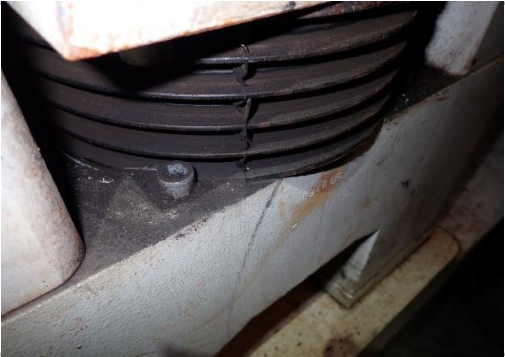
9.02	Gearbox mounting hardware	Moderate wear on elastomer bearings

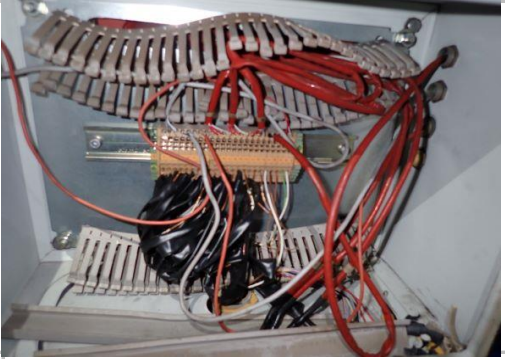
Item	System / Component	Comments	Photo	Class
10.01	Generator cover condition			1
10.02	Generator feet torque markings			1
10.03	Cooling system/circuit			1
10.04	Lubricant system			1
10.05	Generator bearings			1
10.06	Generator slip ring			1
10.07	MV cable condition, strain relief	Melting of raceway and signs of excessive heat to cables

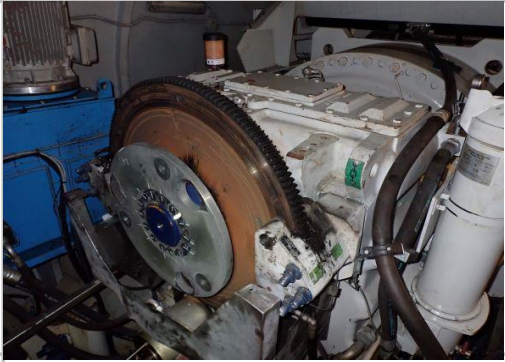
10.10	Flexible coupler condition	Not Installed

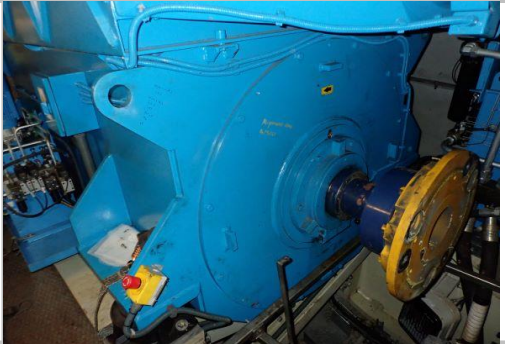
4
10.11	Flexible coupler torque marks			1
10.12	Flexible coupler safety cover	Protection cover missing with hardware; not installed

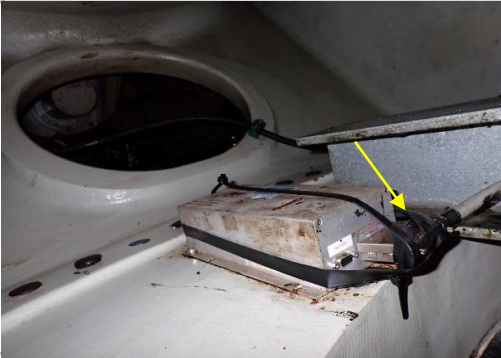
Item	System / Component	Comments	Photo	Class
14.01	Vibration switch	Harting plug on PCH sensor secured with zip ties and electrical tape

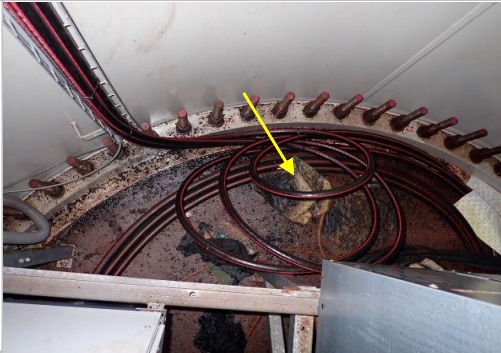
1.09	Tower door hinges and lock			1
1.10	Tower door screens and filters			1
1.11	Cleanliness of basement area	Saturated rags and severe oil leakage on basement floor

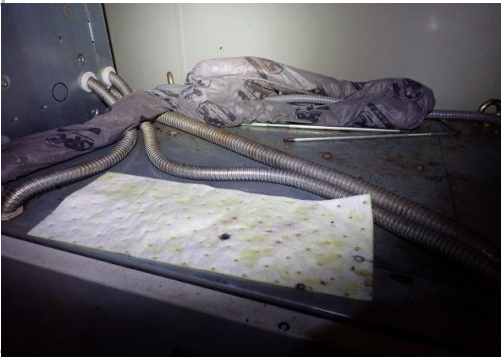
Item	System / Component	Comments	Photo	Class
2.01	Main control cabinet			1
2.02	Control panel			1
2.03	Cooling system			1
2.04	Converter			1
2.05	Breakers, switches, fuses			1
2.06	Cabling, splices			1
2.07	Grounding			1
2.08	Fans & filters			1
2.09	Light fixtures & LV			1
2.10	HV Switch gear cabinet	Saturated pig mat on cabinet

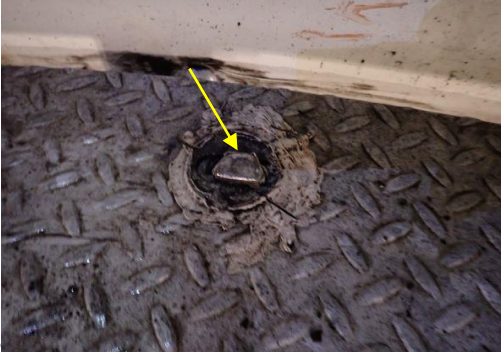
5.01	Platform condition	Loose/damaged bolt on platform

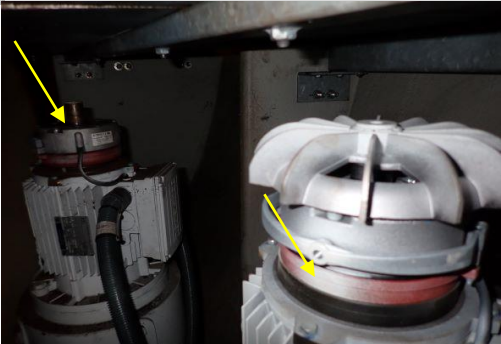
Item	System / Component	Comments	Photo	Class
5.11	Yaw motors condition	Missing protection cover and cooling fan

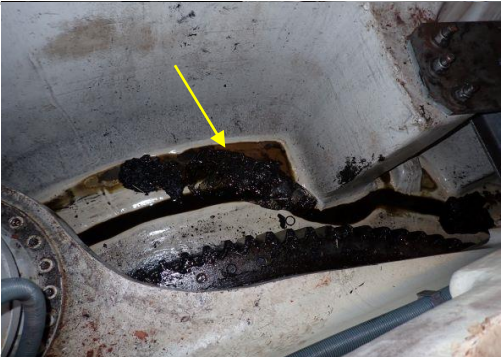
5.12	Yaw motors oil level, leakage	Severe grease leakage on nacelle structure/housing

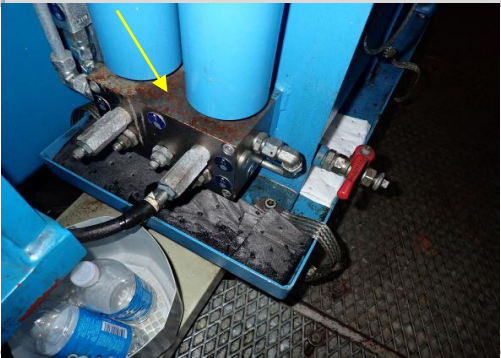
Item	System / Component	Comments	Photo	Class
6.01	Hydraulic pump condition	Moderate corrosion on hydraulic block; mild leakage

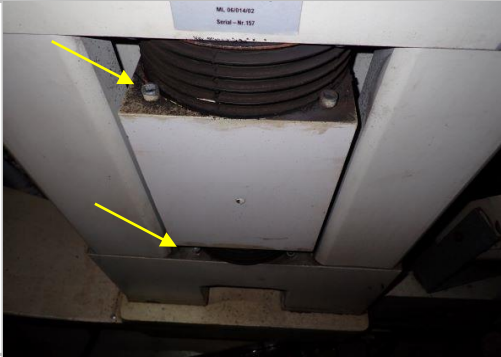
9. Gearbox				
Item	System / Component	Comments	Photo	Class
9.01	Gearbox cover condition			1
9.02	Gearbox mounting hardware	Elastomer bearing wear - moderate

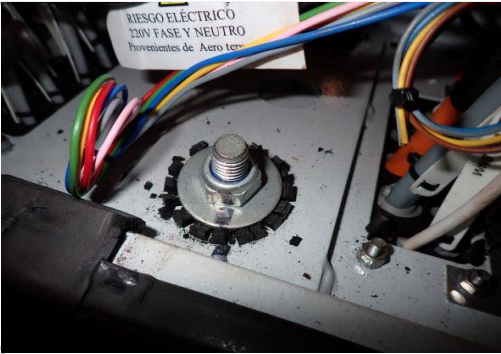
11.01	Control cabinet condition	Top box mounting bushing - excessive wear

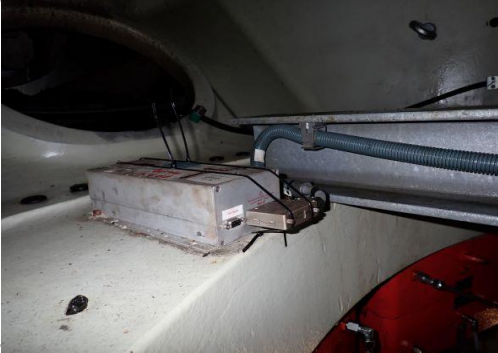
Item	System / Component	Comments	Photo	Class
14.01	Vibration switch	Ziptied harting plug on PCH sensor

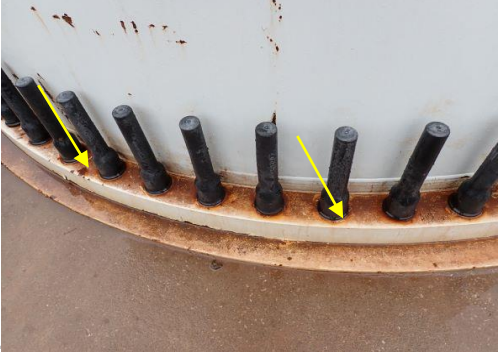
1.02	Foundation bolts condition	Moderate corrosion and aint chipping near base of foundation bolts

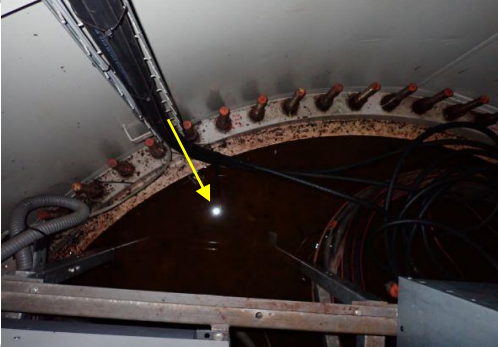
2
1.07	Tower door condition			1
1.08	Tower door flange and seals			1
1.09	Tower door hinges and lock			1
1.10	Tower door screens and filters			1
1.11	Cleanliness of basement area	Severe Flooding/oil in basement floor

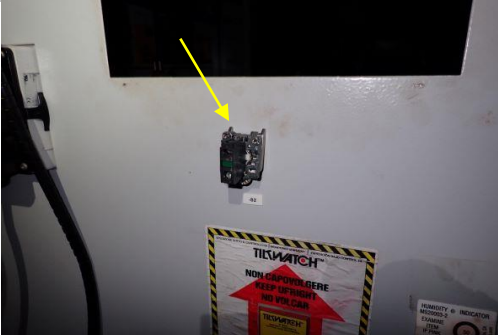
Item	System / Component	Comments	Photo	Class
2.01	Main control cabinet	Key operation connection not connected

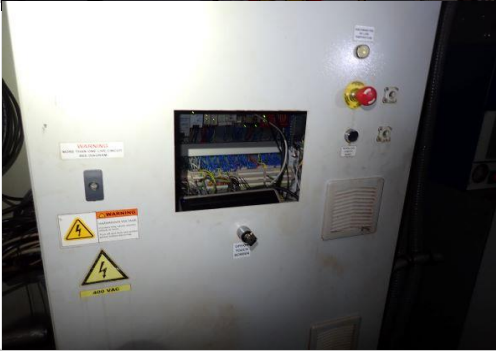
2.02	Control panel	Missing CPU interface

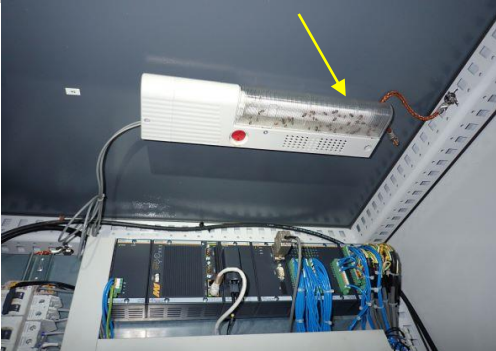
2
2.03	Cooling system			1
2.04	Converter			1
2.05	Breakers, switches, fuses			1
2.06	Cabling, splices			1
2.07	Grounding			1
2.08	Fans & filters			1
2.09	Light fixtures & LV	Cabinet light not functioning

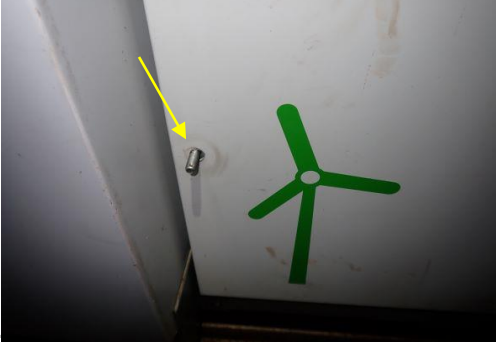
2
2.10	HV Switch gear cabinet	Cabinet missing hardware

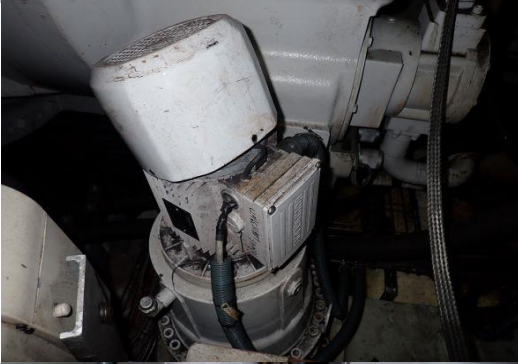
Yaw Components				
Item	System / Component	Comments	Photo	Class
5.11	Yaw motors condition	Missing protection cover hardware

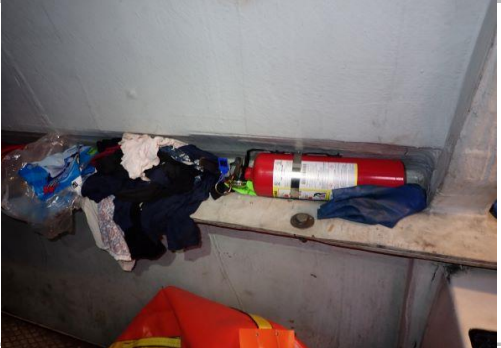
Item	System / Component	Comments	Photo	Class
7.01	Main frame structural condition			1
7.02	Fiberglass condition, seams	Saturated rags and fire extinguisher left on nacelle fiberglass

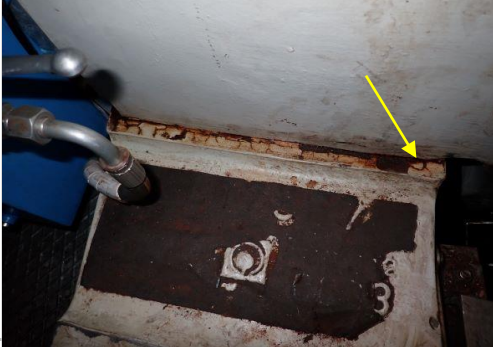
Item	System / Component	Comments	Photo	Class
9.01	Gearbox cover condition			1
9.02	Gearbox mounting hardware	Moderate corrosion and paint chipping near feet of gearbox

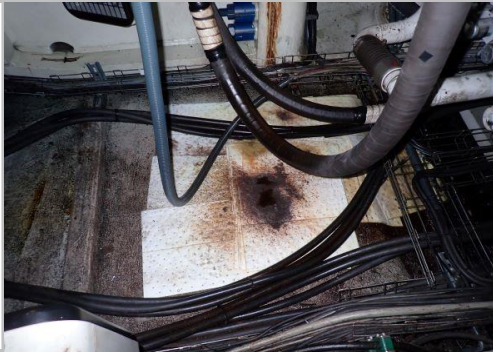
2
9.03	Gearbox access ports			1
9.04	Cooling system/circuit			1
9.05	Lubrication pump system			1
9.06	Breather filter condition			1
9.07	Gearbox oil level	Saturated pigmat under gearbox
