HERMANVILLE-CLEARSPRING WIND DEVELOPMENT

Turbine Inspection and Condition Evaluation

Prince Edward Island Energy Corporation

Document No.: 10341259-HOU-R-01

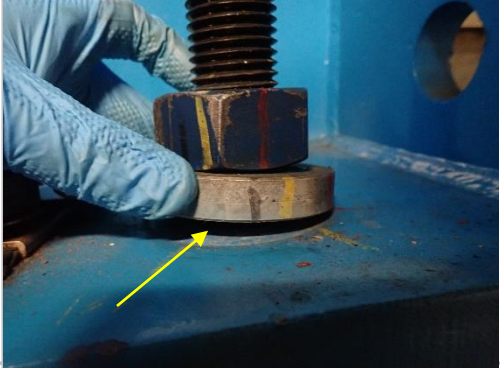
10.02	Generator feet torque markings	Loose hardware at foot of generator - generator foot loosened by hand. Re-torque required.

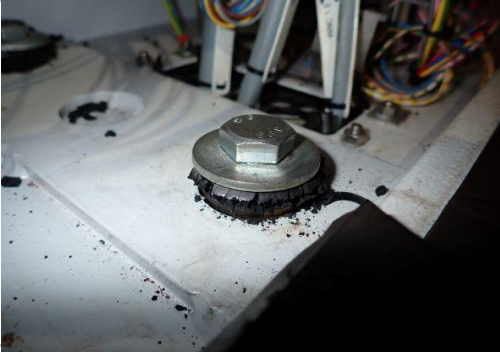
Item	System / Component	Comments	Photo	Class
11.01	Control cabinet condition	Top box mount/bushings damaged

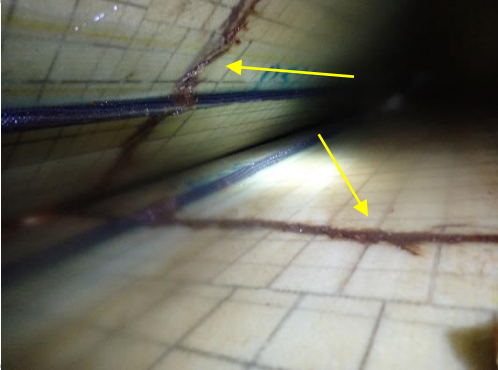
Item	System / Component	Comments	Photo	Class
13.01	Blade structural condition	Chordwise TE cracking at R13

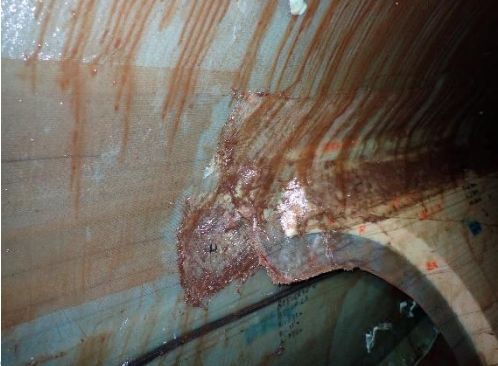
13.05	Blade cleanliness	Blade internal saturated with oil/grease

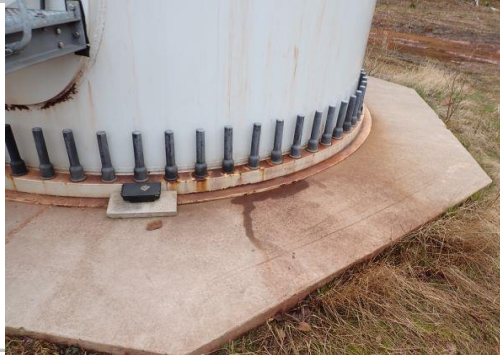
1.01	Foundation concrete condition	Moderate corrosion and paint chipping forming on base of foundation bolts

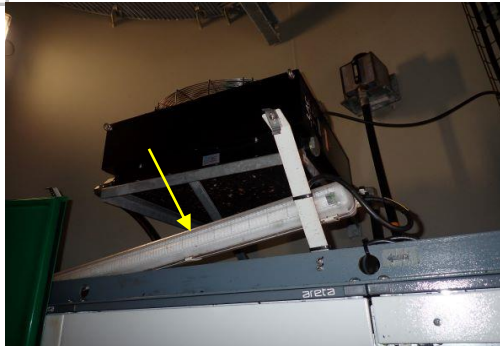
Item	System / Component	Comments	Photo	Class
2.01	Main control cabinet			1
2.02	Control panel			1
2.03	Cooling system			1
2.04	Converter			1
2.05	Breakers, switches, fuses			1
2.06	Cabling, splices			1
2.07	Grounding			1
2.08	Fans & filters			1
2.09	Light fixtures & LV	Light not functioning; bracket damaged

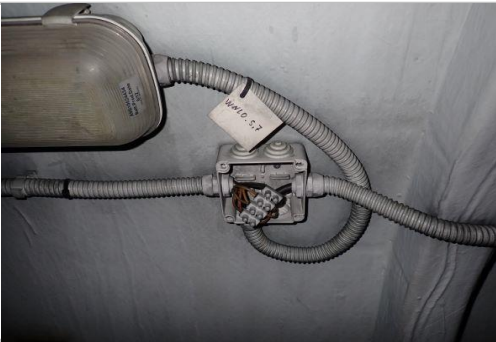
4.29	Light fixtures and LV	Open junction box to light fixture

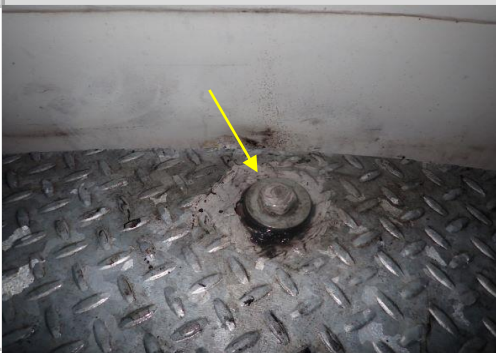
Item	System / Component	Comments	Photo	Class
5.01	Platform condition	Loose platform hardware

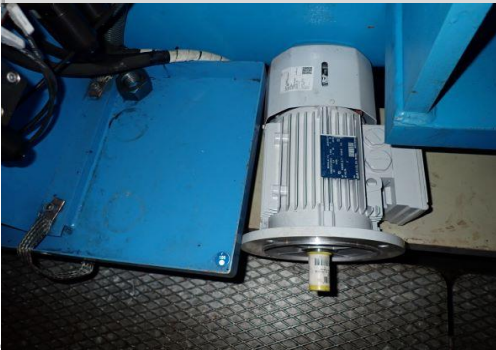
Item	System / Component	Comments	Photo	Class
5.11	Yaw motors condition	Yaw motor laying on nacelle platform

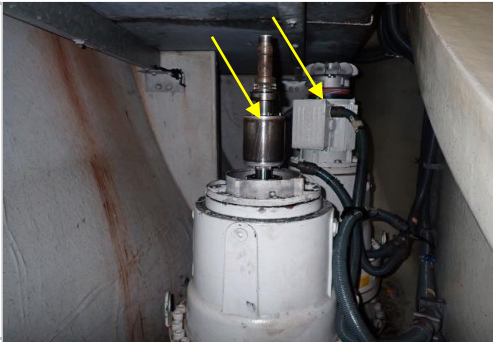
5.13	Yaw gear condition	Multiple yaw motors missing key components

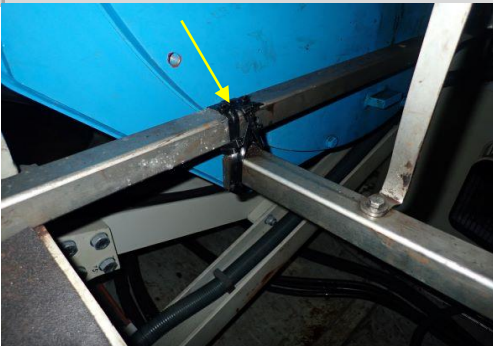
Item	System / Component	Comments	Photo	Class
7.01	Main frame structural condition	High speed shaft cover structure being held by zip ties

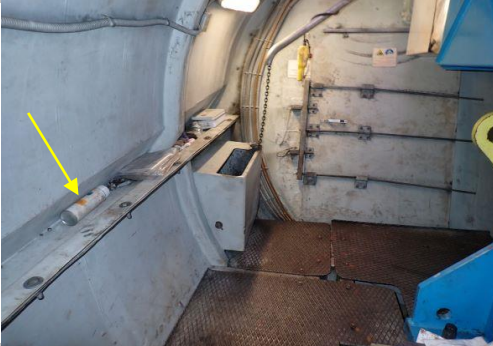
2
7.02	Fiberglass condition, seams	Debris left on fiberglass seams

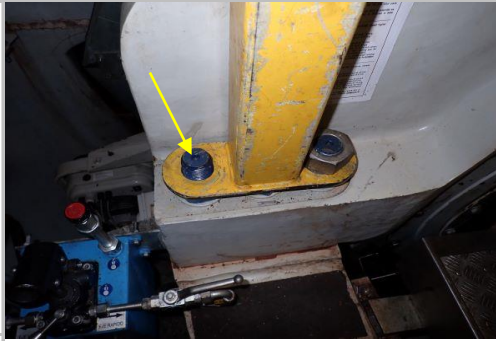
7.07	Nacelle hardware, condition	Missing hardware on main bearing support structure bracket

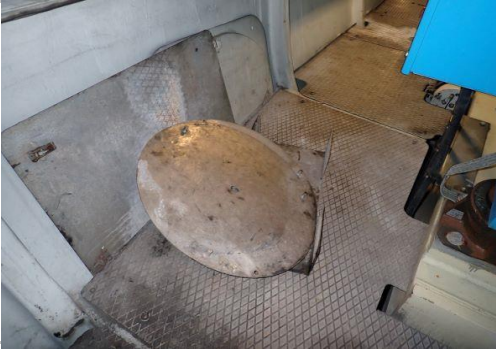
2
7.08	Hub adapter bolts, condition			1
7.09	Rotor lock condition			1
7.10	E-stop functionality			1
7.11	Hoist condition			1
7.12	Hatches, condition	Hatches/hardware left on nacelle platforms

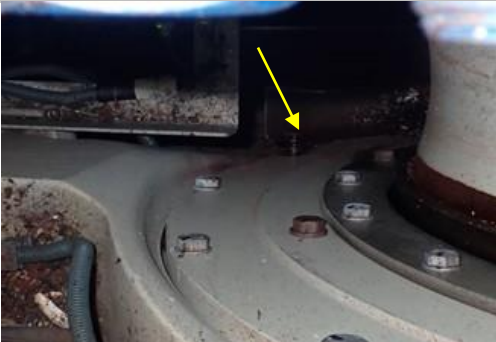
Item	System / Component	Comments	Photo	Class
8.01	Main bearing condition			
8.02	Main bearing mounting hardware	Loose hardware on drive end of main bearing retainer plate

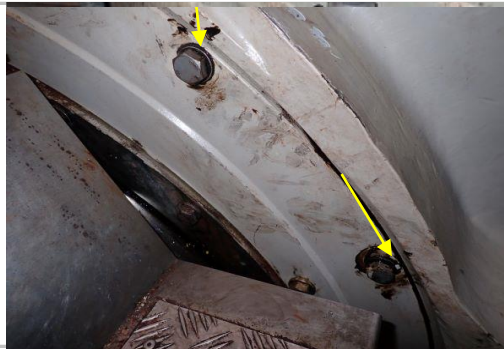
8.03	Main shaft condition	Loose hardware

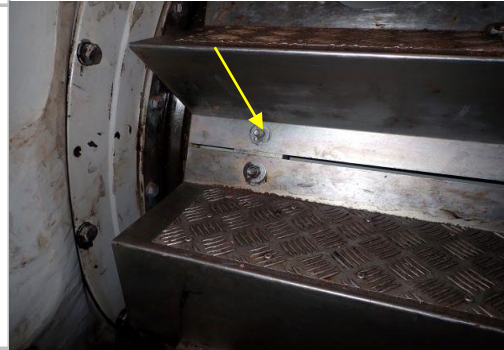
Item	System / Component	Comments	Photo	Class
9.01	Gearbox cover condition			
9.02	Gearbox mounting hardware	Broken hardware on gear box platform stairs

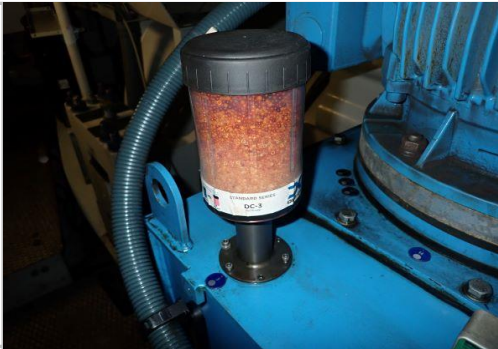
10.04	Lubricant system	Oversaturated oil filter

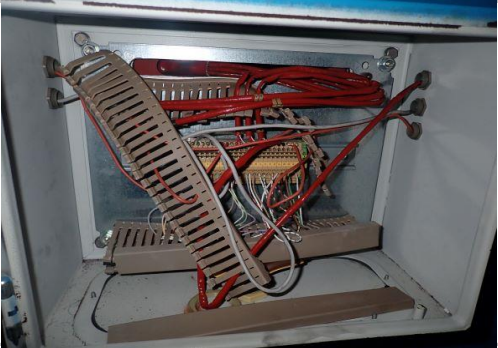
2
10.05	Generator bearings			1
10.06	Generator slip ring			1
10.07	MV cable condition, strain relief	melting of raceway and signs off excessive heat to cables

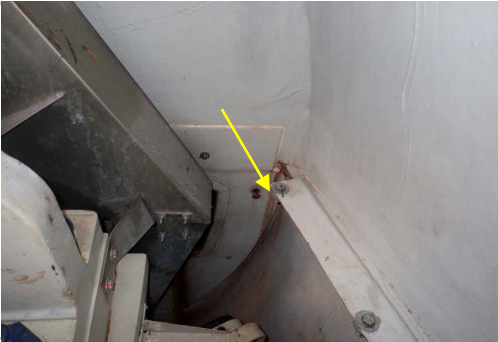
12.01	Mounting hardware condition	Loose hardware near hub entry

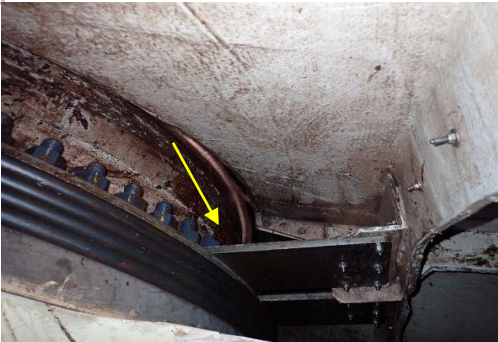
2
12.02	Access hatch condition			1
12.03	Blade bearing seals	Moderate grease leak forming in hub structure

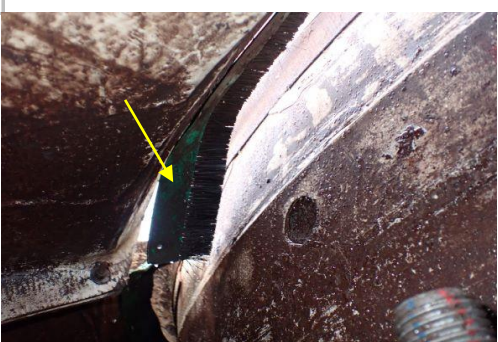
2
12.04	Fiberglass nose cone condition			1
12.05	Cleanliness hub internal	Missing blade protection near hub entry

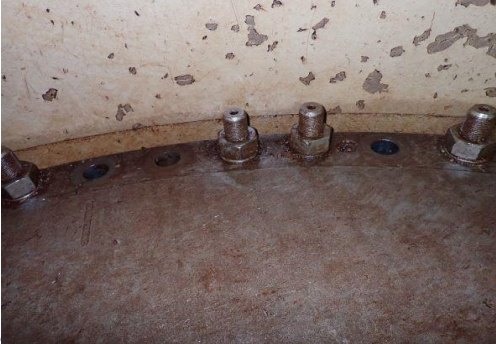
Blade 3				
Item	System / Component	Comments	Photo	Class
13.11	Blade structural condition			1
13.12	Blade connection torque	3 blade studs missing/damaged

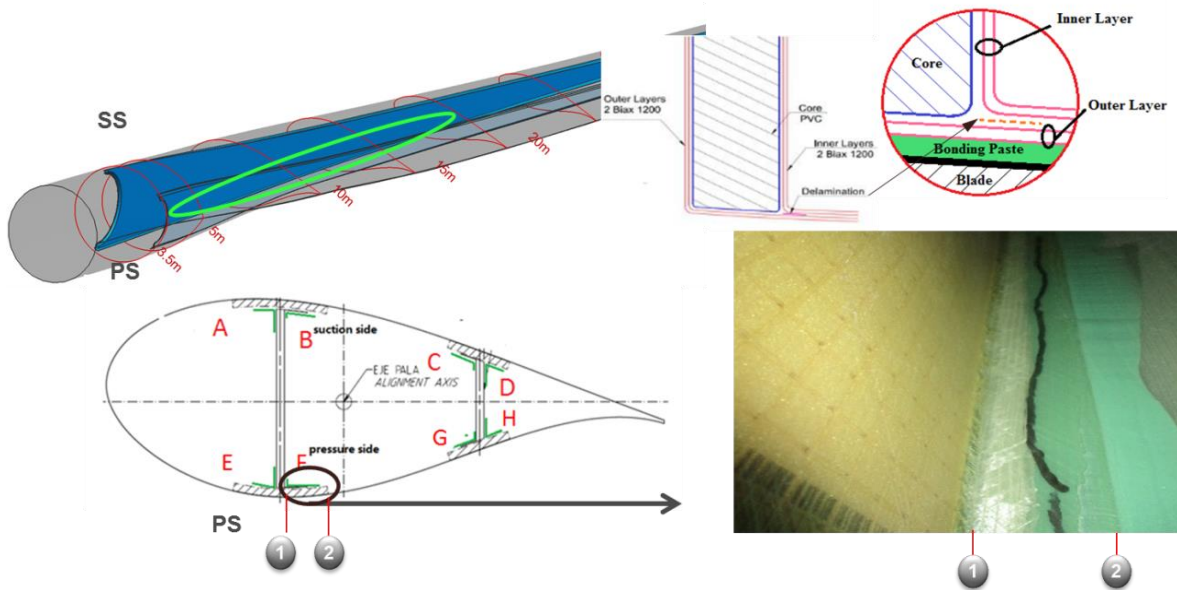
Figure 4-3 Shear web delamination (figure provided by AWP)

Delamination occurs on the trailing edge side of the main shear web, at the corner between the face sheet and flange of the shear web. The red dashed line in Figure 4-3 shows the location of the delamination initiation. Spanwise location of the delamination varies. Both 56.7 m (AW116) and 61.2 m (AW125) blade models have been found with delamination.

Delamination occurs in nearly all cases on the pressure side flange of the shear web. Several instances of delamination have been found on the suction side of the blade, however these instances are far less frequent and may be related to progression of web separation under the shear web (see Section 4.6.2.6 below).

AWP's hypothesis is that air bubbles (voids) and a resin-rich area in the corner where delamination appears to initiate are resulting in stress concentrations, and sufficient energy is available to allow the delamination to initiate and progress. AWP's analyses reasonably show that delamination may initiate and propagate under normal loading in the presence of flaws such as voids in the corner of the web flange. In DNV's experience, resin-rich areas in shear web flange corners, and voids in these resin-rich areas, are common in blades, yet delamination at this location due to these features is uncommon. Nonetheless, in DNV's opinion, AWP's hypothesis explaining delamination is generally reasonable, and AWP has identified the contributing factors that are likely leading to the delamination.

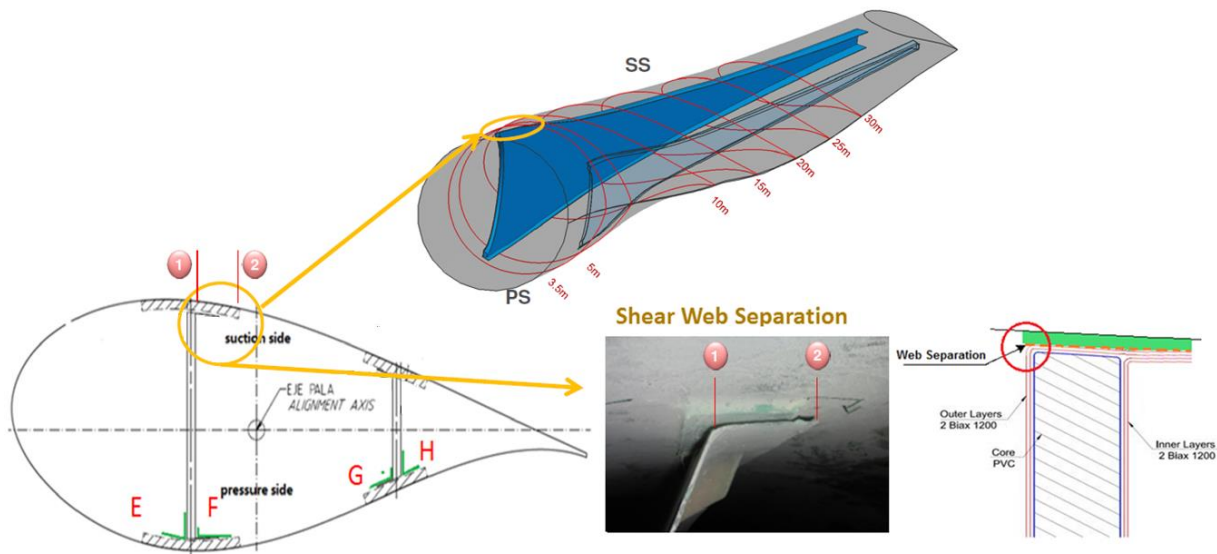
Figure 4-4 Shear web separation (figure provided by AWP)

Web separation occurs along the bond between the main shear web flange and shell. Partial to full separation has been observed from R3.5 to beyond R20. Web separation occurs in nearly all cases on the suction side of the shear web. Instances of separation have been found on the pressure side of the blade, however pressure-side separation is far less frequent than suction-side separation.

For web separation, AWP’s hypothesis is that a defect in the web-to-shell bond is present, and the defect is of sufficient severity that normal loading leads to crack initiation and progression to web separation. In DNV’s opinion, AWP’s hypothesis explaining web separation is generally reasonable.
